2020 Municipal Bridge Inspection Report

**Municipality of South Bruce
21 Gordon St. E, P.O. Box 540
Teeswater, ON N0G 2S0**

**R.J. Burnside & Associates Limited
449 Josephine Street P.O. Box 10
Wingham ON N0G 2W0 CANADA**

**September 2020
300042391.2020**

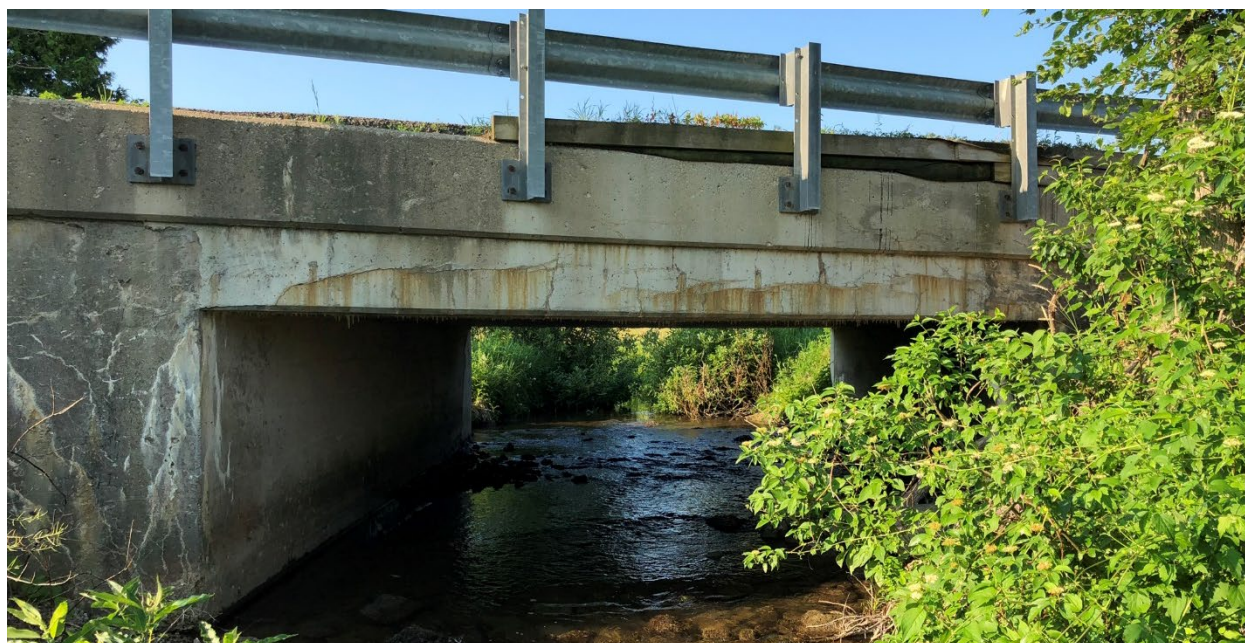
Structure No. 0001 is generally in fair to poor condition with large areas of unsound concrete noted throughout and a considerable amount of additional fill placed over the deck (300-400 mm) that the structure may not have been intended to carry. There is evidence of a previous rehabilitation to the structure, but the date is unknown. Due to road profile adjustment requirements associated with additional fill on the deck and given a previous rehabilitation has been completed, it is recommended that the Municipality forgo an additional rehabilitation and replace the structure. Due to the condition of the deck and wingwalls, replacement is recommended within approximately 4 years. Alternatively, the Municipality may wish to complete a study into the economical feasibility of repairing the structure versus replacing it to determine the best course of action. If a rehabilitation is elected, the above noted repairs should be completed within the next year. Consideration should also be given to replacing the steel beam guide rail system to help protect oncoming traffic.

Recommendation: Structure replacement is recommended within 4 years

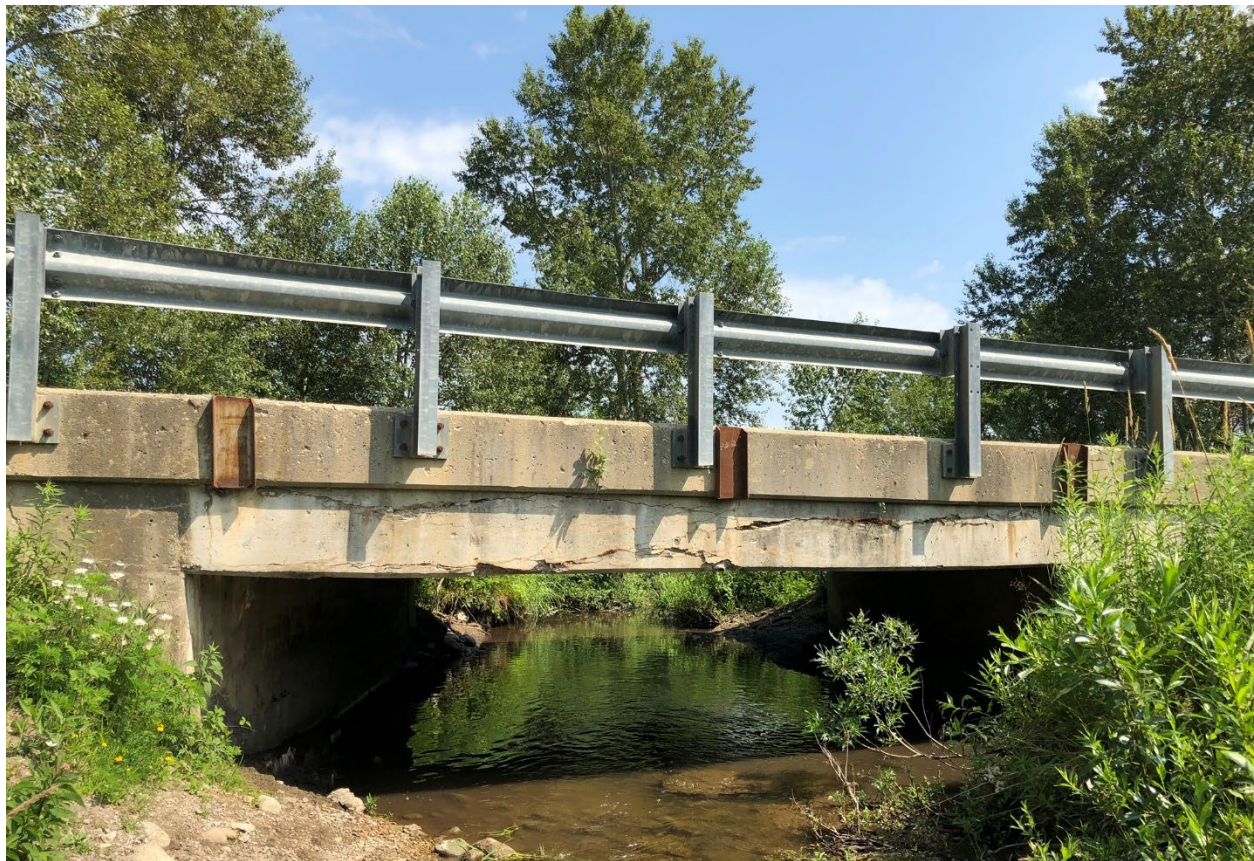
Structure No. 0002, which has evidence of previous rehabilitation work, is generally in fair as well as poor condition with signs of further deterioration since the 2018 inspection. Given the high rehabilitation costs in comparison to the replacement costs, the vintage, narrow width, the small size of the structure, and given the condition of the key structural elements, replacement is recommended within 1 year. Consideration should be given to replacing the existing SBGR to help protect oncoming traffic.

Recommendation: Structure replacement is recommended as soon as possible

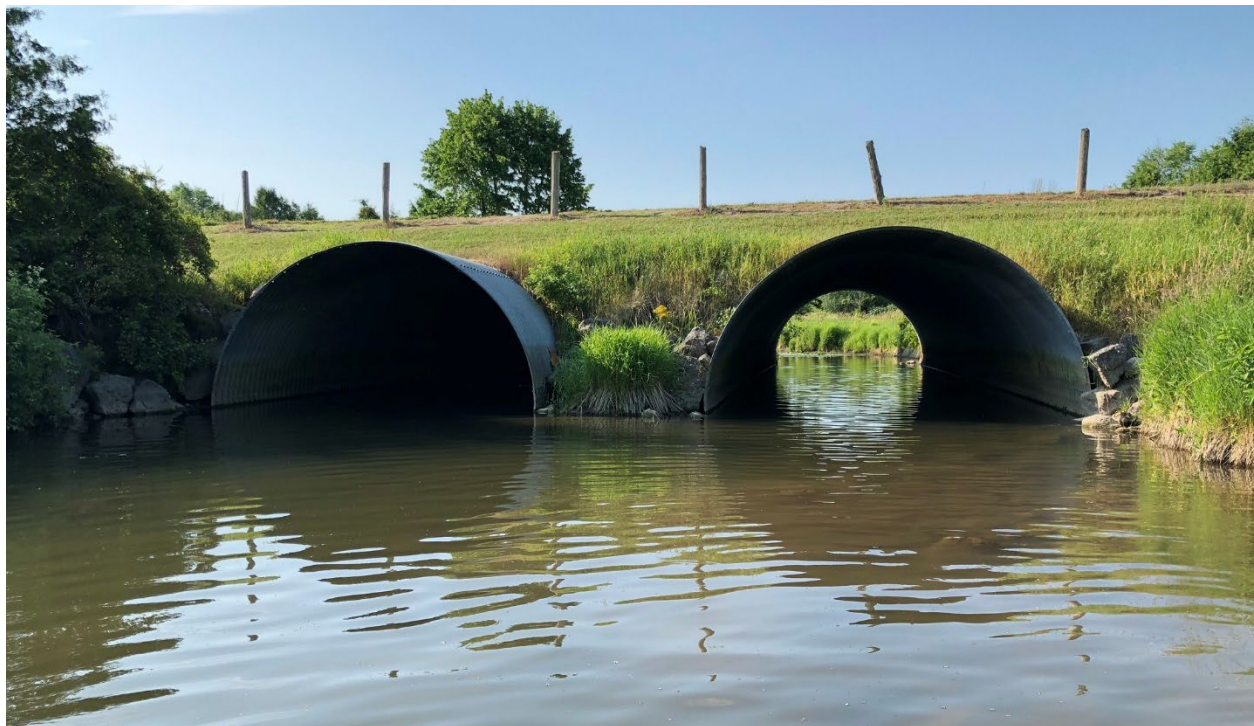
Structure No. 0003 is made up of twin-cell CSP arch culverts which generally appear to be in fair condition and were noted to have bolt hole cracking within the east barrel due to the improper bolting pattern used. Consideration should be given to repairing the bolt hole cracking as soon as possible to prevent further deterioration to the barrel by welding rebar across the cracks or spraying shotcrete beams across the cracked areas. The bolt hole cracking and minor deformation in the west culvert should be monitored closely during future biennial inspections, as these deficiencies affect the structural capacity of the culvert. If the deformation becomes greater than 10% of the culvert diameter, consideration should be given to establishing a monitoring program. In the interim, consideration should also be given to installing a guide rail barrier system over the culverts to help protect oncoming vehicular traffic.

Recommendation: Minor Rehabilitation is recommended within 1 years

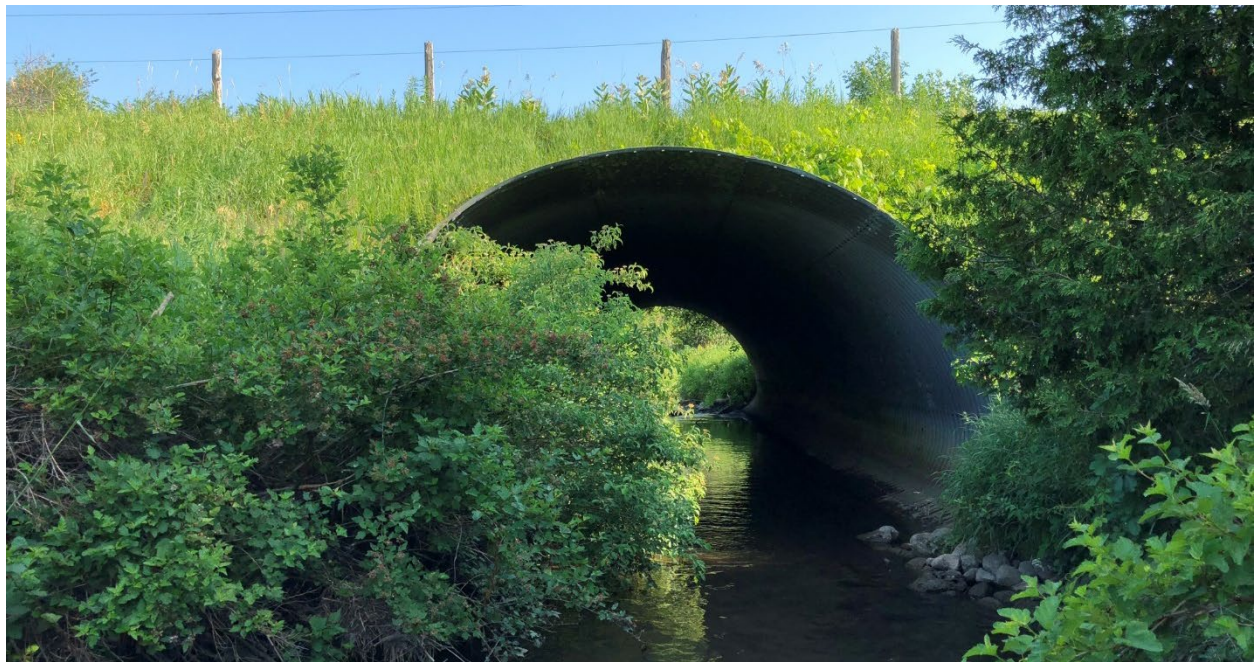
Structure No. 0004 generally appears to be in good condition showing no major signs of deterioration outside of typical surface corrosion. Improper bolting patterns are present on the structure which are prone to bolt hole cracking in the areas of concentrated stress at the tighter radius plates; however, no cracks were noted at the time of inspection. These areas, as well as the minor plate cusping on the top of the culvert should be closely monitored during future inspections. If the plate cusping deformation becomes greater than 10 mm, consideration should be given to establishing a monitoring program. Based on the current BCI, replacement should be scheduled in approximately 17-18 years if the BCI continues to drop at a rate matching the projected deterioration curves typical of this structure type. In the interim, consideration should be given to installing a proper guide rail barrier system over the structure to help protect oncoming vehicular traffic.

Recommendation: No Capital Works is estimated to be required within the next 10 years

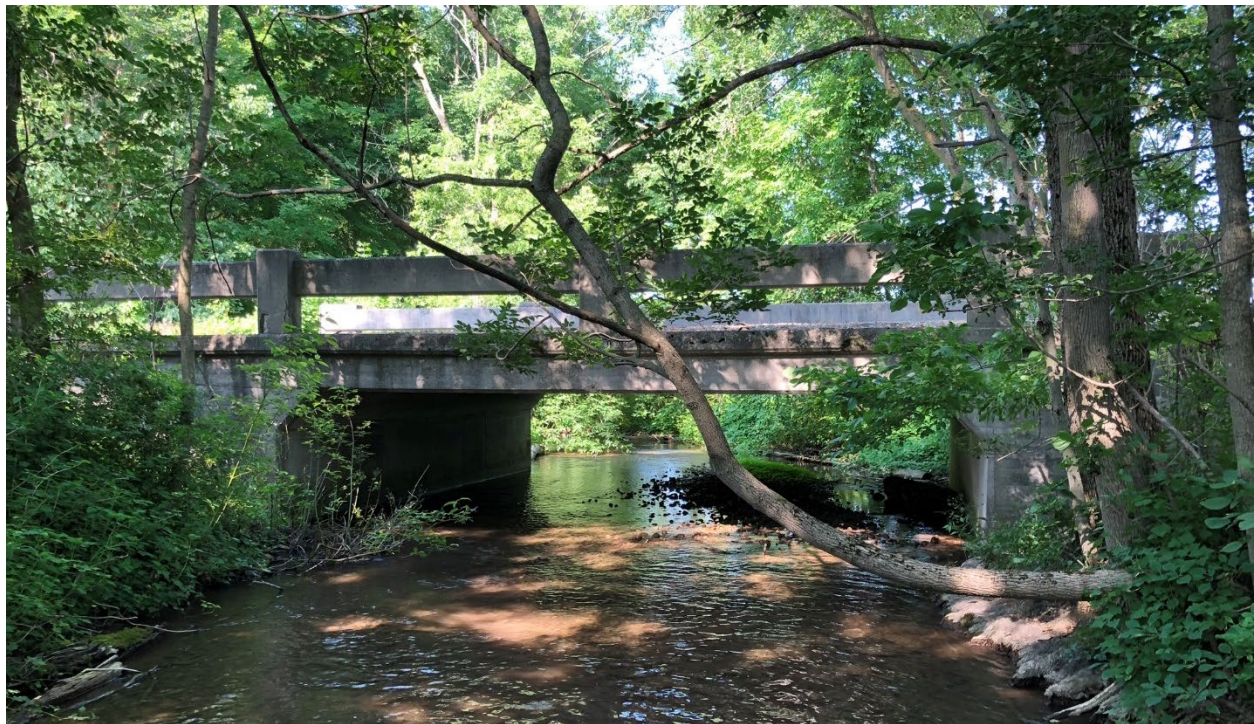
Structure No. 0005 is a concrete rigid frame structure that is over 65 years old but generally appears to be in good to fair condition with localized concrete deficiencies noted. This structure is an ideal candidate for future rehabilitation work as the BCI approaches 60, which is estimated to occur in approximately 5 years time based on typical degradation curves for this structure type. However, the BCI should be monitored in future biennial inspections and the years to rehabilitation can be adjusted accordingly. Rehabilitation work consisting of concrete repairs, barrier replacement, waterproofing and paving and guide rail installation is recommended. If rehabilitation works are not scheduled for within the next 5 years, consideration should be given to installing approach guide rail to protect on coming traffic from the safety hazard of the exposed barrier ends.

Recommendation: Minor Rehabilitation is recommended within 5 years

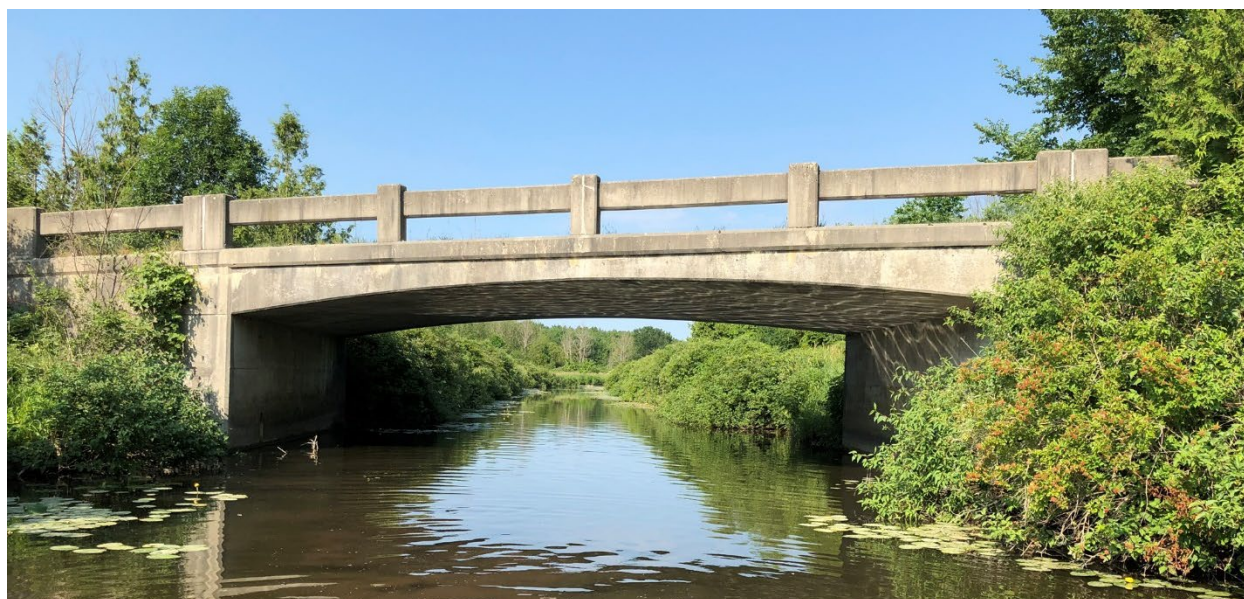
Structure No. 0006 generally appears to be in good condition showing only very localized concrete deficiencies. The deficiencies do not appear to have progressed since 2016, which can be partly attributed to the Municipality sealing the joints in the barriers to help prevent further water and salt laden damage. Based on the current BCI, this structure should be scheduled for rehabilitation work in approximately 6-7 years based on typical deterioration rates for this structure type. However, the BCI should be monitored in future biennial inspections and the years to rehabilitation can be adjusted accordingly. During the rehabilitation it is recommended to remove the fill from above the bridge and waterproof and pave the structure to help extend the service life of the bridge. It is also recommended that the barrier be replaced with a current code conforming system. In the interim, consideration should be given to installing approach guide rail as soon as possible to help protect oncoming vehicular traffic from the exposed concrete barrier ends.

Recommendation: Minor Rehabilitation is recommended within 7 years

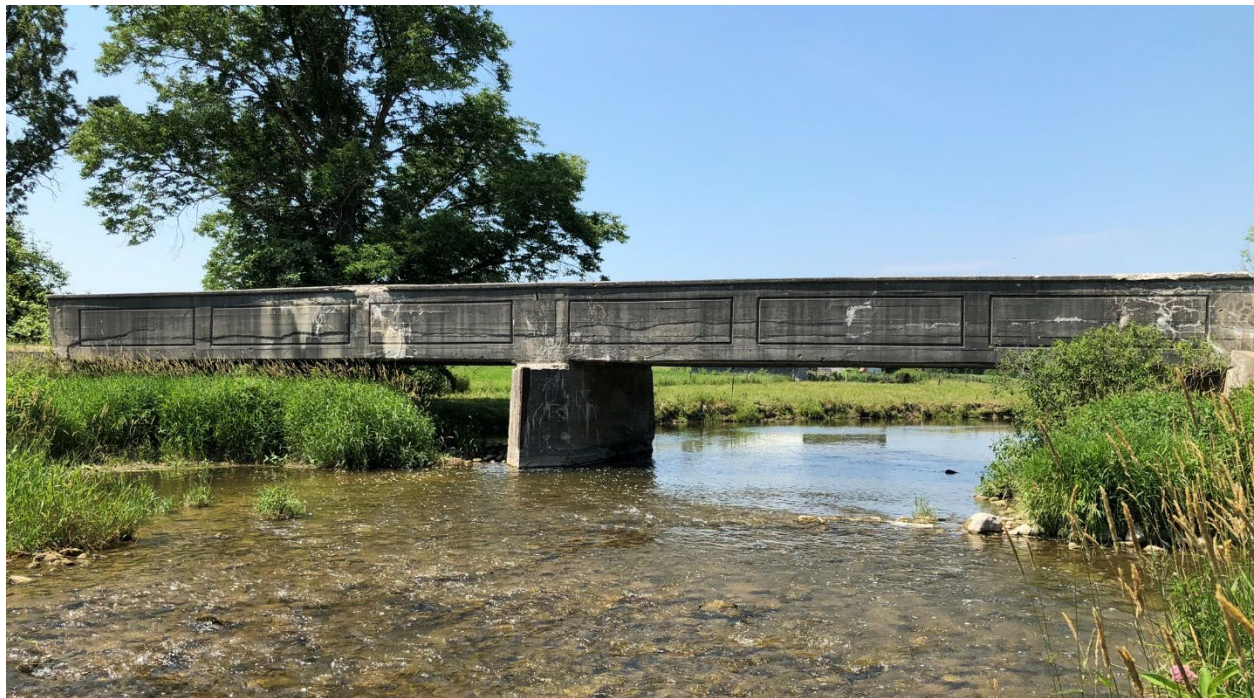
Structure No. 0007 is over 105 years old and generally in poor condition with severe concrete deterioration. A detailed deck condition survey was completed in 2015/2016 and determined that rehabilitating the existing concrete is not a feasible option. Therefore, given the vintage, type of the structure (single load path) and the amount of poor concrete observed in the key structural elements, replacement should be scheduled within approximately 1 year with a full two-lane structure. A crack monitoring program was initiated in November 2015 to review the wide cracking and concrete deterioration for any further signs of movement. No significant further movement was observed and therefore the bridge can continue to be monitored during future biennial inspections until replacement occurs.

Recommendation: Forgo rehabilitation and replace structure within 1 year

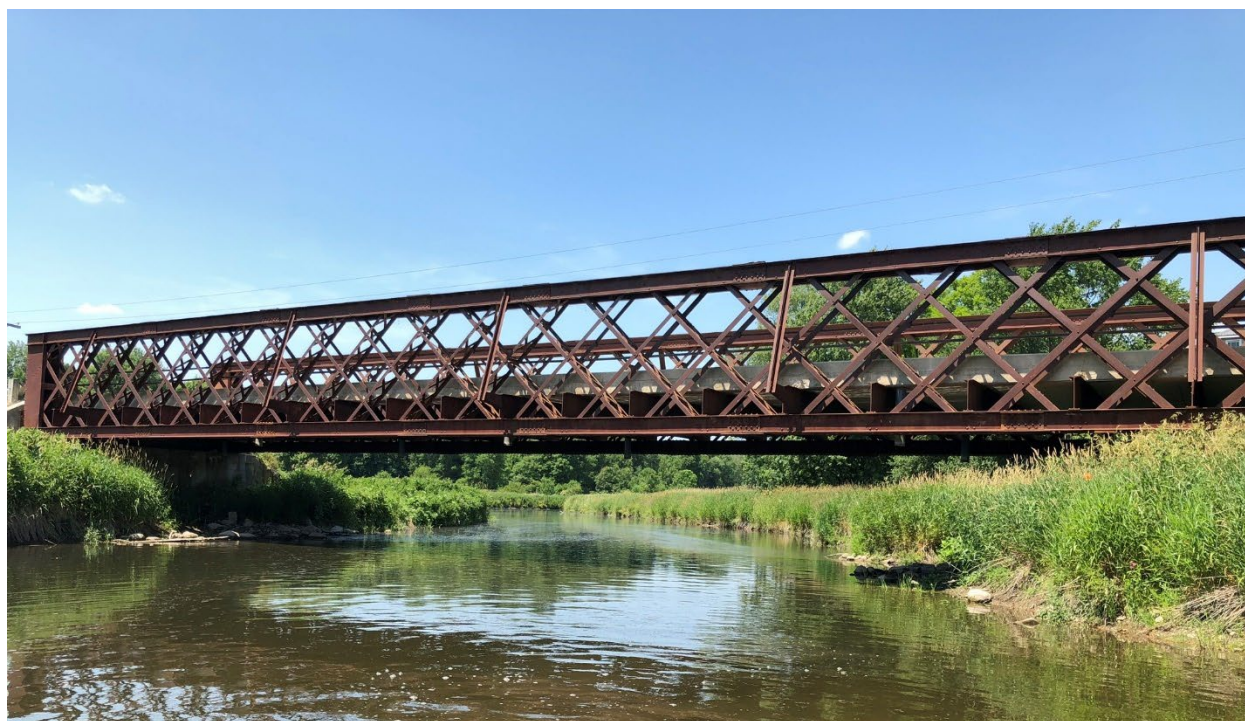
Structure No. 0008 is over 75 years old, with evidence of a previous major rehabilitation to the structure. Generally, the bridge appears to be in fair condition with signs of corrosion and areas of localized minor to moderate section loss to the structural steel members. Typically, a bridge of this nature would be rehabilitated for a second time when the BCI approaches 60 and often replaced when the BCI reaches 40. Given the relatively high cost of replacement, the Municipality may wish to complete a second major rehabilitation in approximately 2 years when the BCI reaches 60. Replacement would most likely be required in approximately 12 years if no rehabilitation work is completed. Given the vintage of the structure and the corrosion noted, a load limit evaluation may be completed prior to the rehabilitation.

Recommendation: Major Rehabilitation is recommended within 2 years

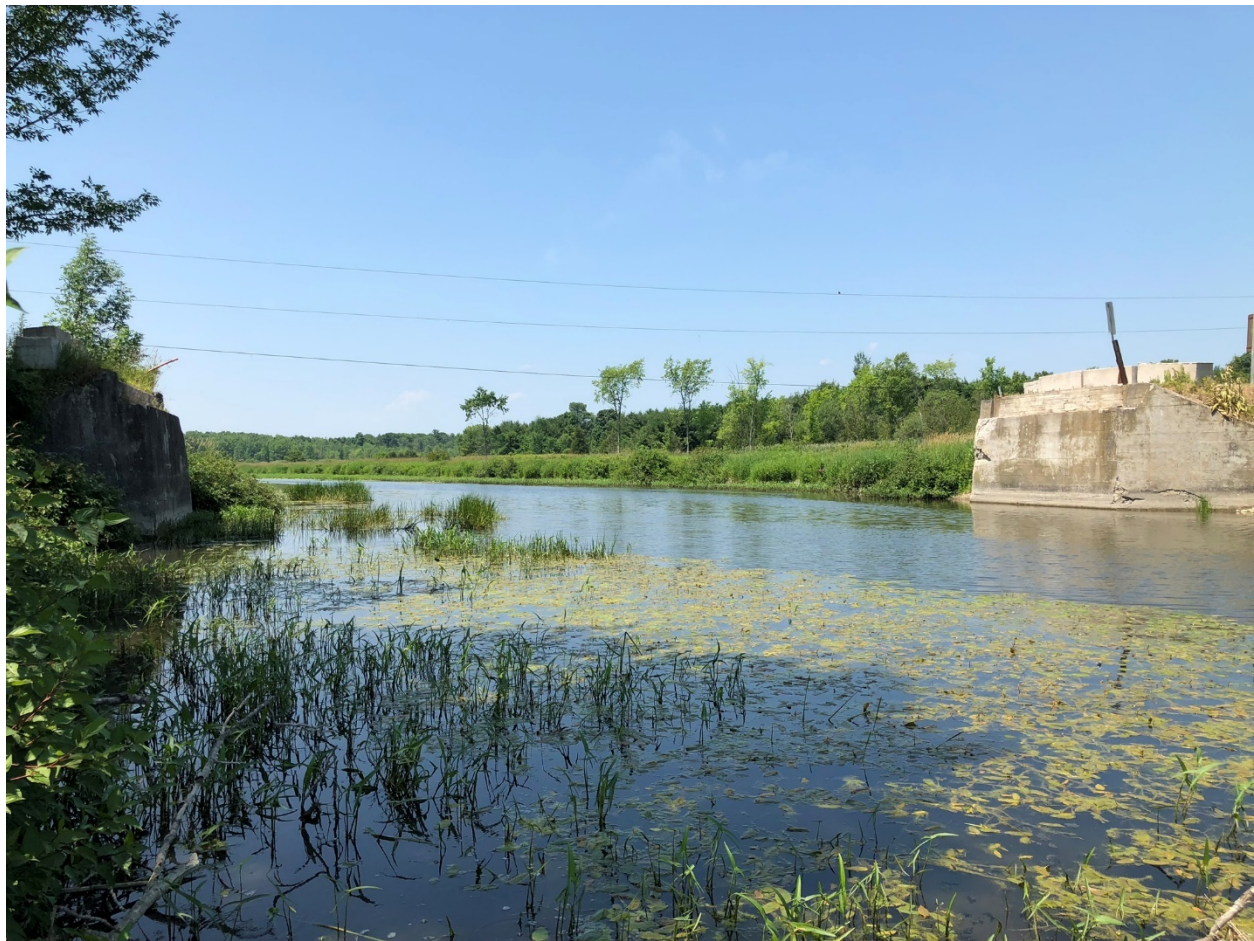
Structure No. 0009 was hit by Municipal snowplow in 2013 and has since been closed to traffic. The superstructure has been removed and only the original abutments remain currently. The abutments have large areas of unsound concrete noted by hammer tapping but appear stable at this time. No further action is recommended at this point in time.

Recommendation: No further action is recommended at this point in time.

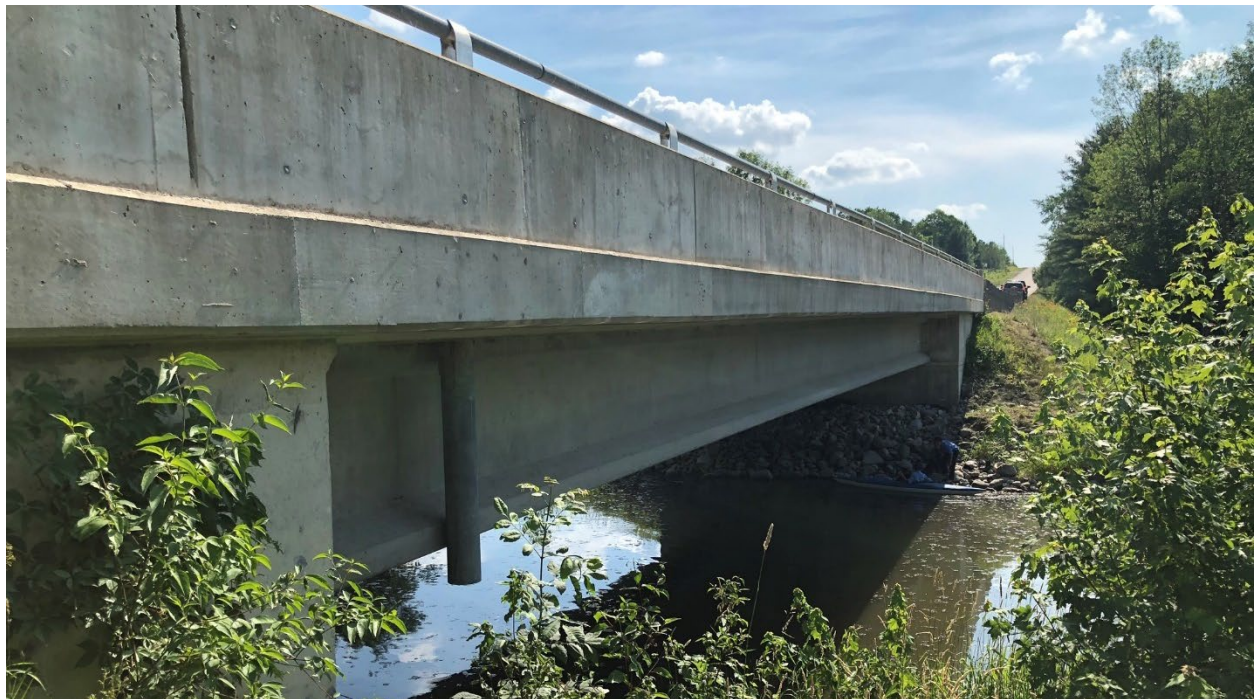
Structure No. 0010 was constructed in 2009 and is generally in excellent condition; however, the approach slabs have experienced significant settlement, which was likely caused by substandard compaction efforts during construction. This settlement does not appear to be actively progressing when compared to previous inspection measurements, but it presents a rough riding surface for traffic. The settlement should continue to be monitored during future biennial inspections and the Municipality may wish to complete the repairs if the settlement is no longer actively progressing. Anticipated repairs would include removing the curbs, milling and padding the asphalt and replacing the curbs. Alternatively, jacking of the slab using a polyurethane epoxy injection could also be completed. In addition, consideration should be given to repairing the guide rail end treatments as it appears that they were installed incorrectly during construction.

Recommendation: Minor Rehabilitation is recommended within 2 years

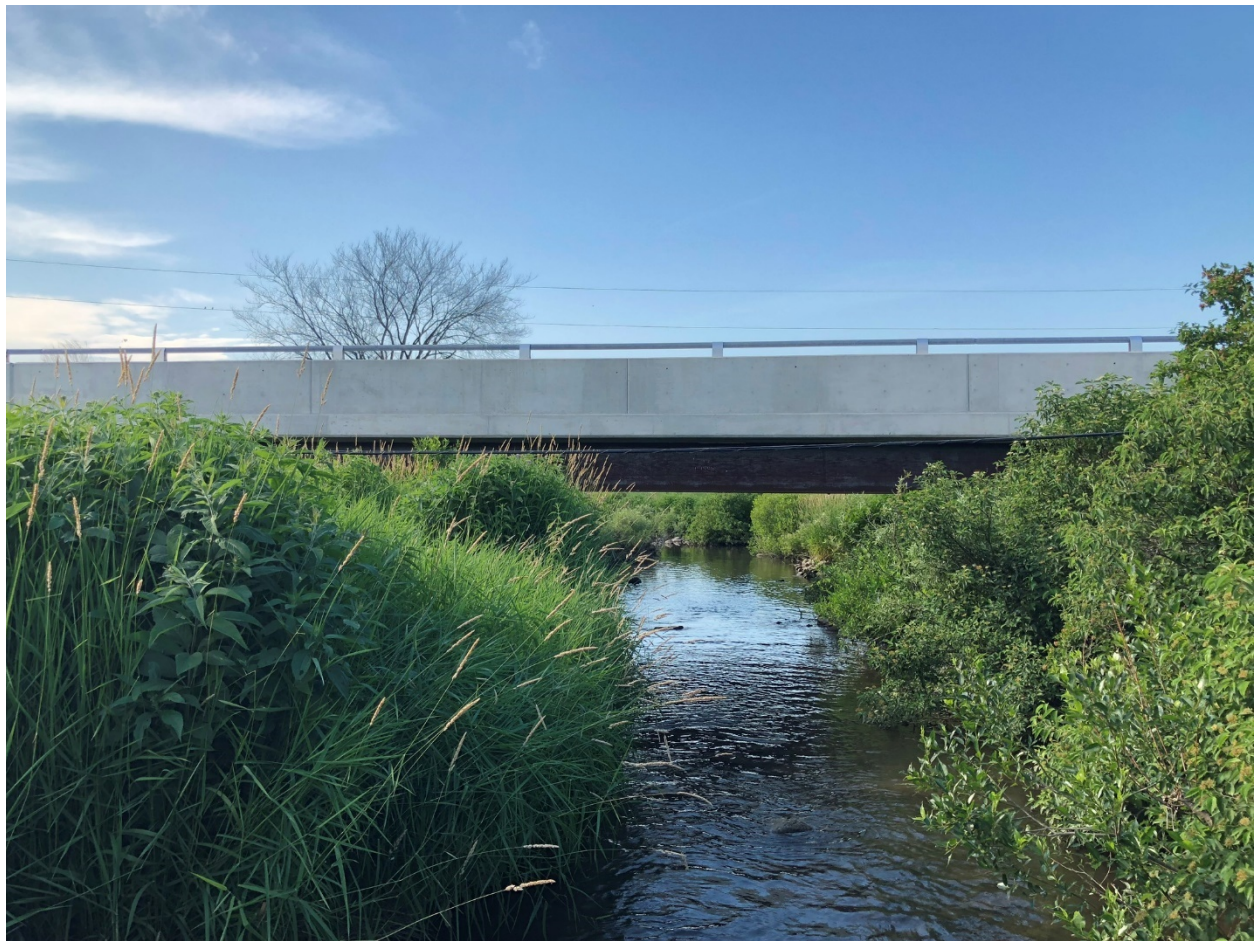
Structure No. 0011 is a concrete deck on steel I-girder structure which was recently constructed in 2018 and is in excellent condition. The new substructure was constructed using perched spread footings behind the existing substructure. The existing substructure remains in place to act as a retaining wall and scour protection but does not support the new structure.

Recommendation: No Capital Works estimated to be required within 10 years.

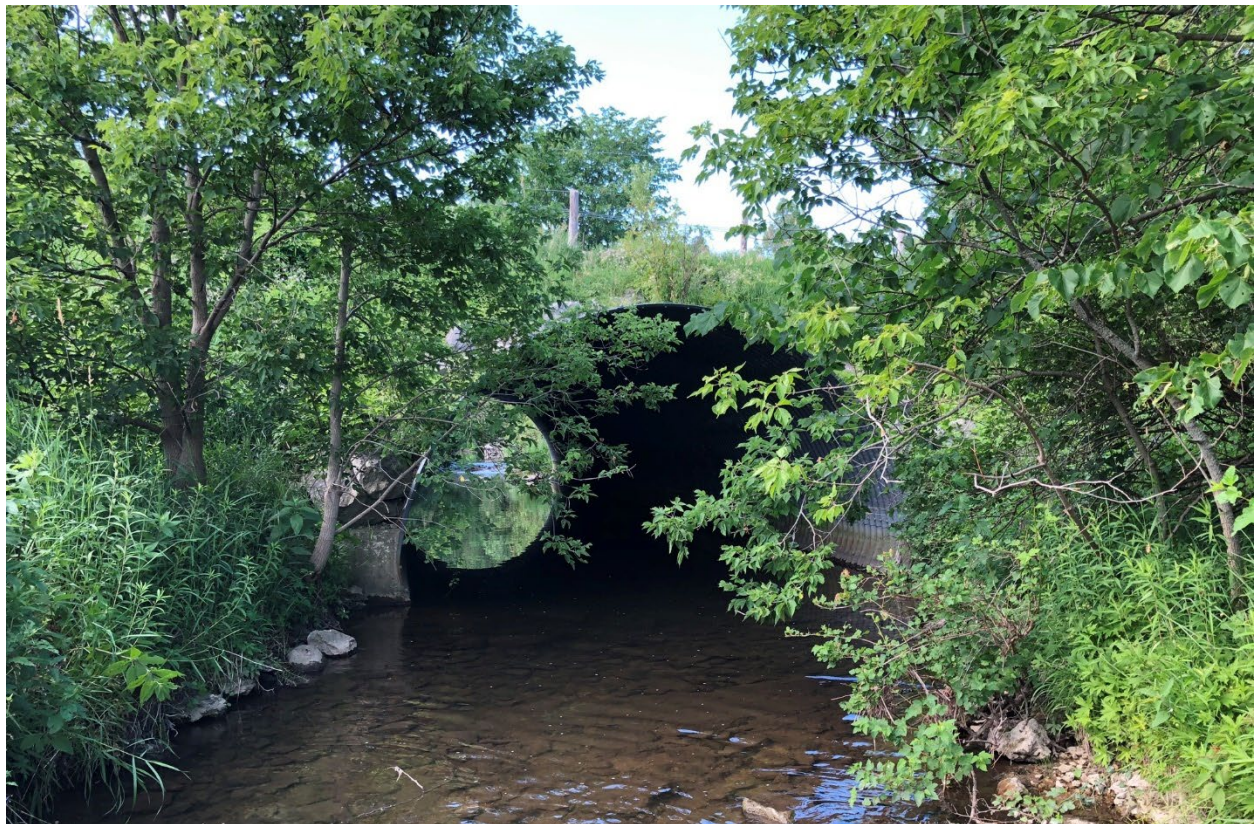
Structure No. 0012 is a CSP multi-plate arch culvert which appears to be in good condition overall. Based on the current BCI, replacement is anticipated to be required in approximately 17-18 years if the BCI continues at a rate matching the typical deterioration curve used for this structure type. However, the degradation rate being experienced appears to be lower than typical curves and therefore the structure may outlast the estimated service life remaining, and the timeline for replacement may be adjusted to suit. In the interim, consideration should be given to replacing the guide rail system with a steel beam guide rail system.

Recommendation: No Capital Works is estimated to be required within the next 10 years

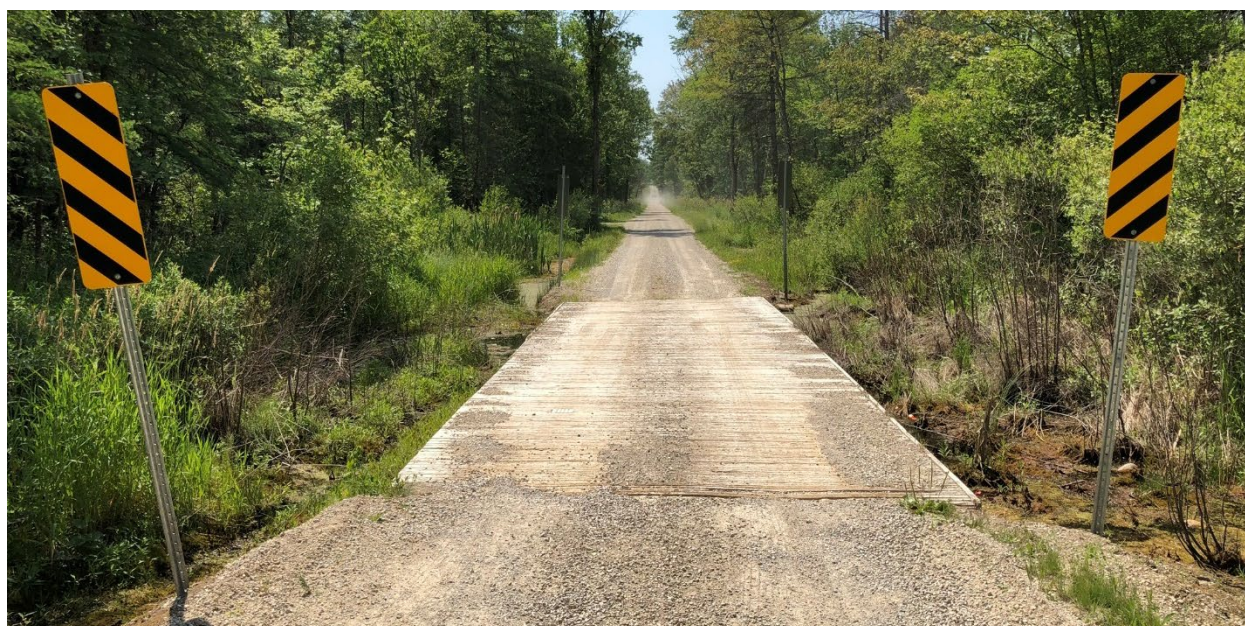
Structure No. 0013 is a narrow, timber structure located on a low traffic road with a 3-tonne load limit. During all past inspections, the inspection of this structure has been limited due to the water elevation being above the soffit elevation. However, it does appear that the abutment is rotating and may be unstable. Also, given the environment and the fluctuating water levels that expose the main load carrying members to intermittent wet conditions, it is anticipated that the timber elements may be experiencing increased deterioration rates. Based on the site conditions, a rehabilitation is not considered economically feasible and the Municipality should consider replacing this structure within the next 5-6 years. It is anticipated that the replacement structure will be at a higher elevation and require road profile adjustments. Replacement cost for a single lane structure is estimated to be approximately \$495,000, which does not include the associated road work. In the interim, the Municipality should complete maintenance work, including the repair of the failed timber curbs and embankment erosion. The stability of the structure should be monitored during future biennial inspections until replacement can occur.

Recommendation: Forgo rehabilitation and replace structure within 6 years

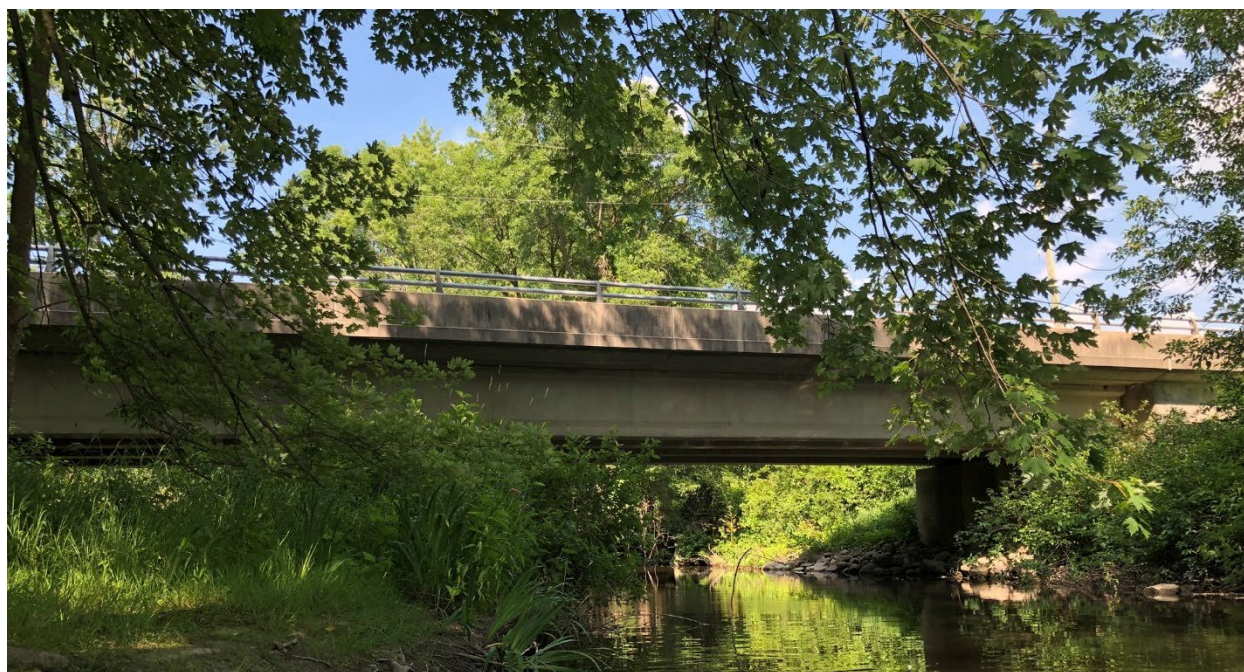
Structure No. 0014, which was built in 1982, appears to be in sound condition with only localized deterioration which does not appear to have significantly increased since the 2018 inspection. However, localized concrete repairs and work to prevent further exposure to salt laden water is recommended to be completed as the BCI approaches 60, which is estimated to occur within approximately 7 years. The rehabilitation work consists of replacing the leaking expansion joints, repairing barrier seals, concrete repairs, waterproofing and paving, which includes staging costs to keep the roadway open to one lane of traffic during construction. If the Municipality would accept full closure of the structure for the duration of the repairs, the staging costs may be removed from the estimate. In the meantime, the maintenance work listed above can be carried out to help reduce deterioration rates.

Recommendation: Minor Rehabilitation is recommended within 7 years

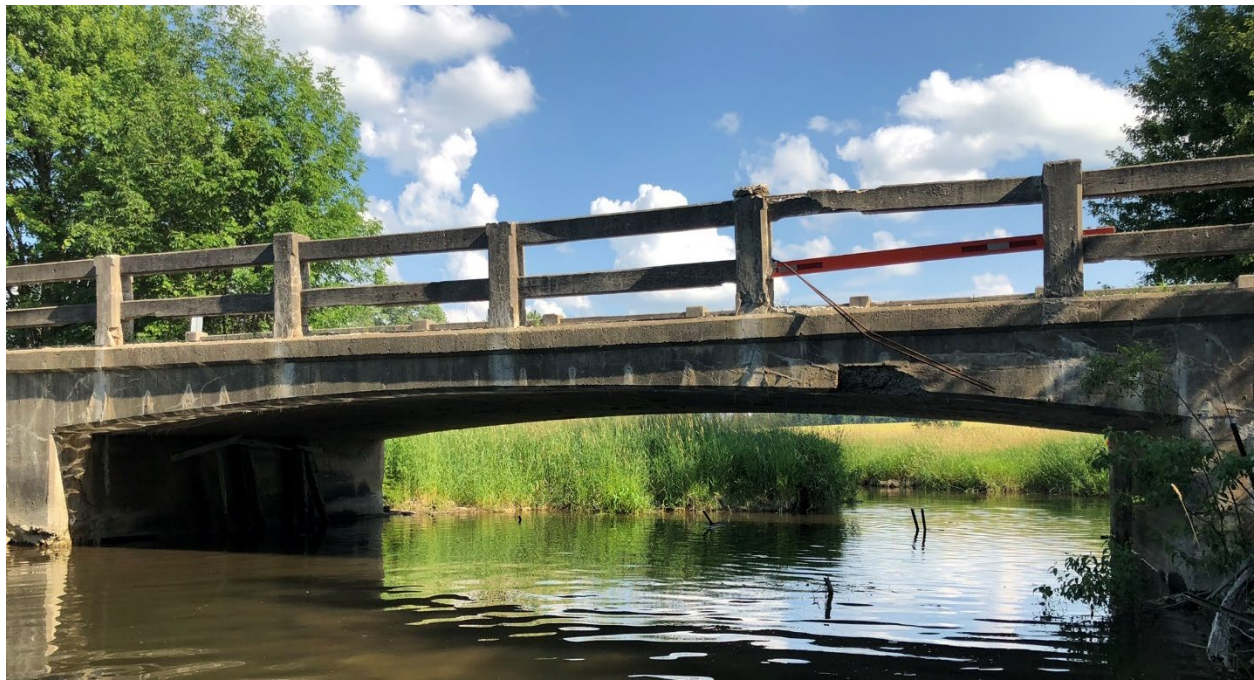
Structure No. 0015 generally appears to be in fair to poor condition and is demonstrating signs of moisture penetration and severe concrete deterioration. A detailed Deck Condition Survey carried out in 2015 revealed approximately 300 mm of saturated granular material above the deck top. Core samples of the deck confirmed high chloride ion content at that time. Although a rehabilitation may have been considered a viable option with the addition of cathodic protection at that time, degradation of the structure has accelerated, and significantly more deteriorated concrete was noted during the 2020 inspection compared to 2018. As such, it is recommended that replacement of this structure occur within approximately 2-3 years.

Recommendation: Forgo rehabilitation and replace structure within 3 years

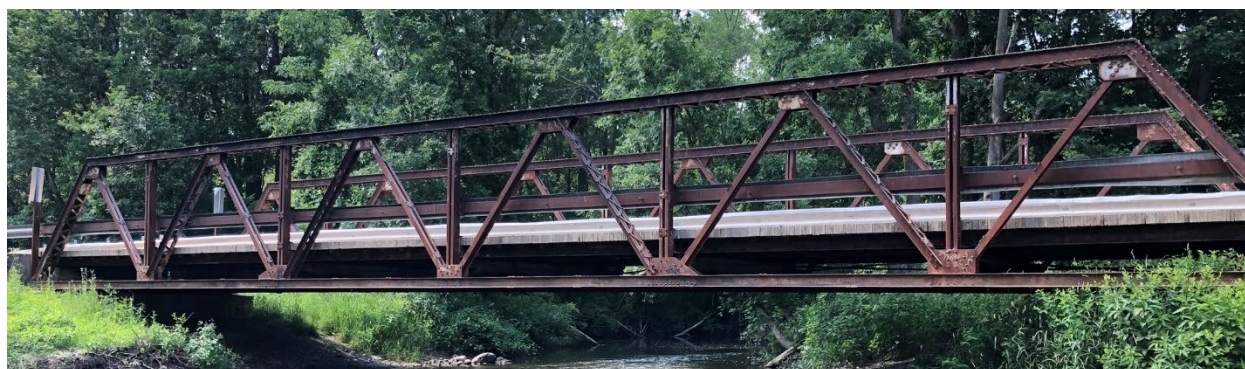
Structure No. 0016 is a steel through truss structure that is over 75 years old and is generally in fair condition overall but is demonstrating signs of very severe section loss and accelerating corrosion since the 2016 and 2018 inspections, specifically on the steel floor beams and stringers. Five of the most severely corroded/perforated stringers were replaced in 2019 in order for the bridge to remain open until further capital works can be completed. Given the progression of corrosion and section loss throughout the steel members, a single load posting of 5 tonnes should be implemented until capital works are complete. Capital works should be planned for as soon as possible. Because this structure likely has heritage value due to its age and structure type, the Municipality may wish to analyze the option of a major rehabilitation as an alternative to replacement. Rehabilitation work would be extensive and would include replacement of the floor beams, stringers and timber decking and repair or replacement of localized members of the main truss system, as well as abutment repairs. However, even after rehabilitation, the structure may still require a load posting of 20/33/41 tonnes (based on the 2016 Structural Evaluation) and the service life of the structure would only be extended by a maximum of 30 years. Additionally, the narrow driving platform and road alignment issues on the approaches would not be addressed in a rehabilitation and therefore the Municipality may find it more economically efficient in the long term to complete a full structure replacement at this time. The load posting should be reduced, and the structure should be monitored until capital works can occur.

Recommendation: Structure replacement is recommended as soon as possible

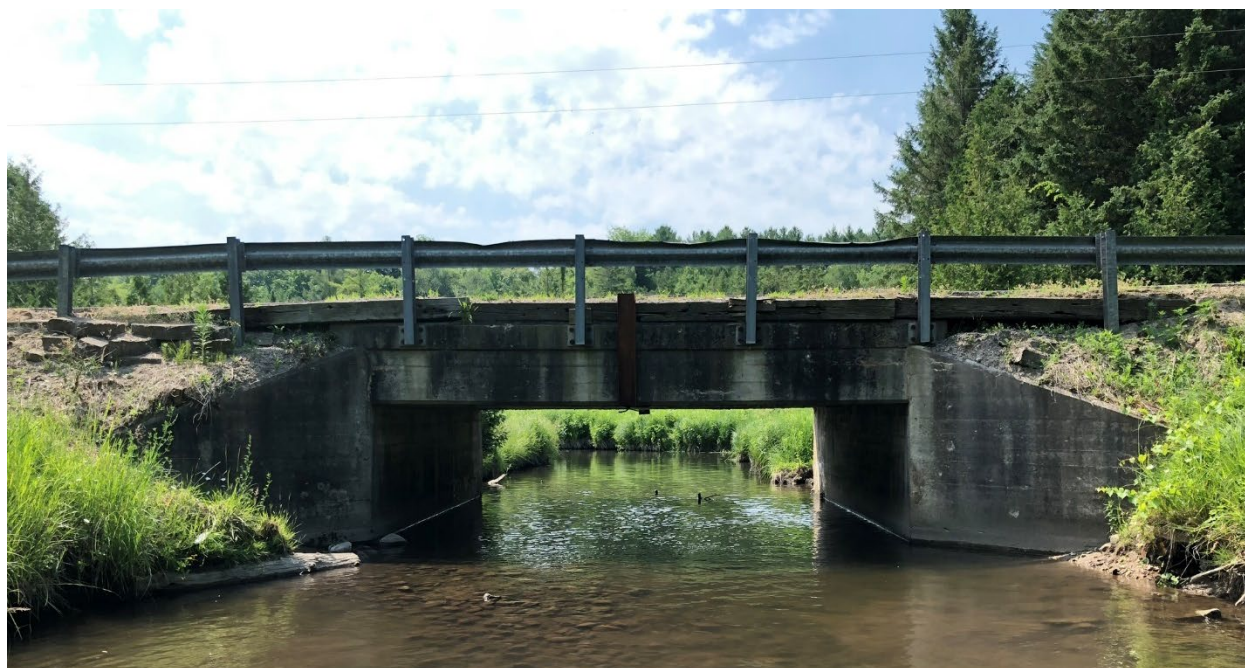
Structure No. 0017 generally appears to be in fair to poor condition with signs of concrete deterioration and moisture penetration which has continued since 2018. There is evidence of previous concrete patch repair work, however these repairs are deteriorating and no longer functioning as intended. The structure may not have been designed to carry the additional dead load of the 0.7 m fill over the structure, which may be contributing to the structure's deterioration. Given the high costs of an additional rehabilitation and that a rehabilitation has already been completed on this structure, it is recommended that the next capital works be replacement. Based on the current BCI and typical deterioration rates, replacement is recommended to be scheduled in approximately 6-7 years. Until replacement is a viable option, it is recommended that Municipal staff and future biennial inspections monitor the timber curbs supporting road fill.

Recommendation: Forgo rehabilitation and replace structure within 7 years

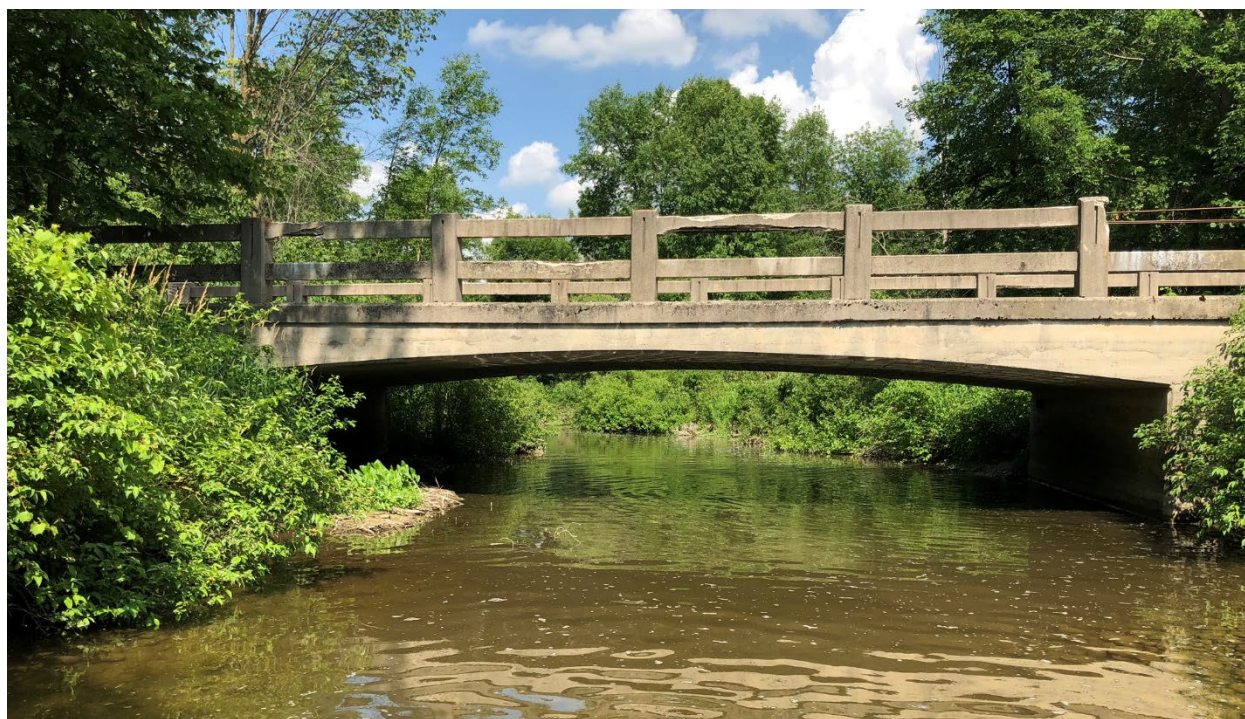
Structure No. 0019 generally appears to be in good condition with the exception of the barrier system. The bridge currently has a 16-tonne load limit posting, which the Municipality may wish to review further if this posting is required based on the observed condition of the structure. Based on the current BCI, it is recommended that rehabilitation work be scheduled within approximately 3 years. The structure may not have been designed to carry the additional dead load of the 0.4 m fill over the structure. Removing the fill over the structure, waterproofing and paving will help extend the service life of the structure. Installing approach steel beam guide rail is also recommended to help protect oncoming traffic from the exposed concrete barrier ends.

Recommendation: Minor Rehabilitation is recommended within 3 years

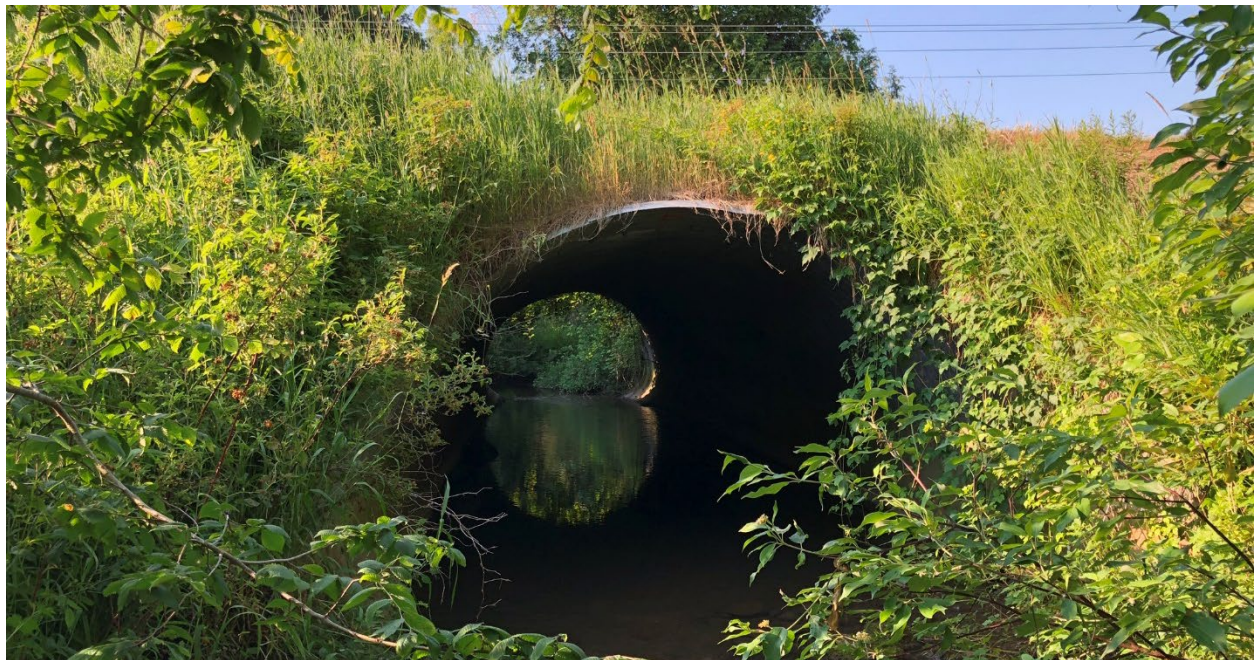
Structure No. 0020 is a CSP multi-plate arch culvert that appears to be in good condition overall with some minor cusping noted and a slightly sagged profile through the barrel. Based on the current BCI, replacement is anticipated to be required in approximately 17-18 years if the BCI trend continues at a rate matching the typical deterioration curve used for this structure type. The minor deformation in the top of the culvert should continue to be monitored closely during future biennial inspections. If the deformation becomes greater than 10% of the culvert diameter, consideration should be given to establishing a monitoring program. The Municipality may wish to investigate if desirable clear zone requirements are met at this structure location or if a guide rail barrier system is required.

Recommendation: No Capital Works is estimated to be required within the next 10 years
