2020 Municipal Bridge Inspection Report

**Municipality of South Bruce
21 Gordon St. E, P.O. Box 540
Teeswater, ON N0G 2S0**

**R.J. Burnside & Associates Limited
449 Josephine Street P.O. Box 10
Wingham ON N0G 2W0 CANADA**

**September 2020
300042391.2020**

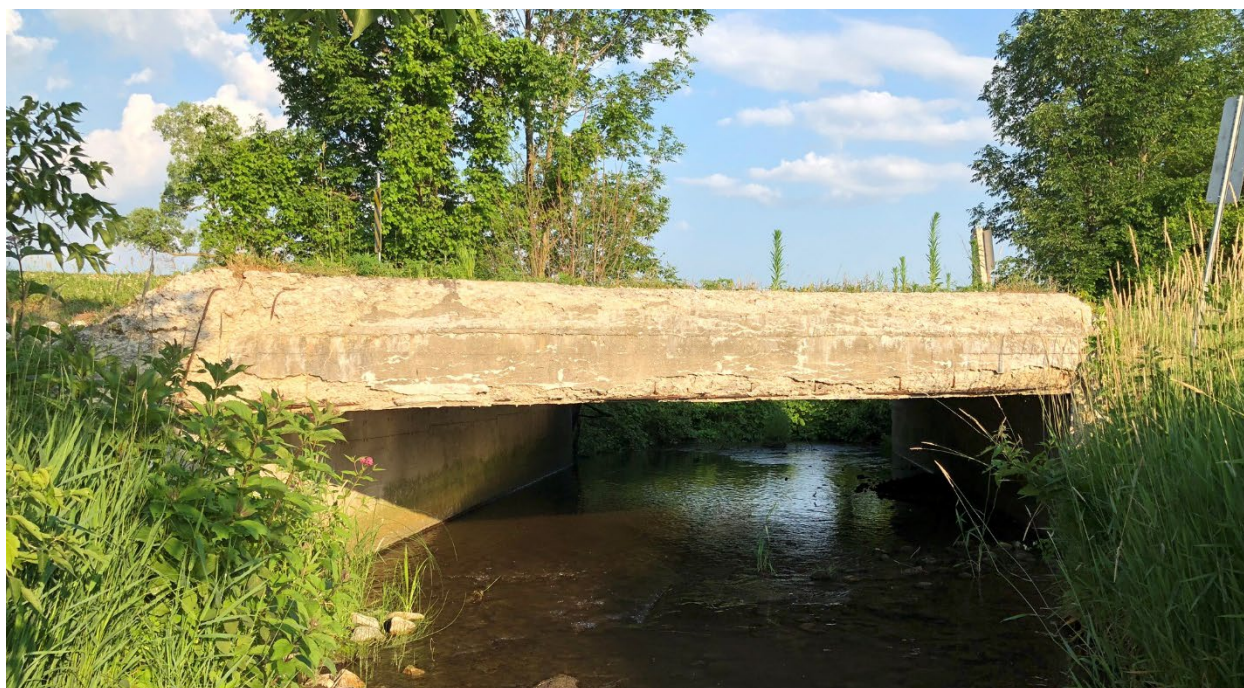
Structure No. 0021 is generally in poor condition with severe disintegration of concrete throughout. Given the vast amount of poor concrete observed, the high rehabilitation costs, and the small span, rehabilitating this structure may not be an economically feasible option. However, if the Municipality wishes to consider rehabilitating the structure, it is recommended that a detailed deck condition survey be completed first to determine if this is a feasible option. Typically, a bridge would be rehabilitated when the BCI approaches 60 and often replaced when the BCI reaches 40. Therefore, based on the current BCI, this structure has surpassed the rehabilitation stage and should be scheduled for replacement within the next 3 years.

Recommendation: Forgo rehabilitation and replace structure within 3 years

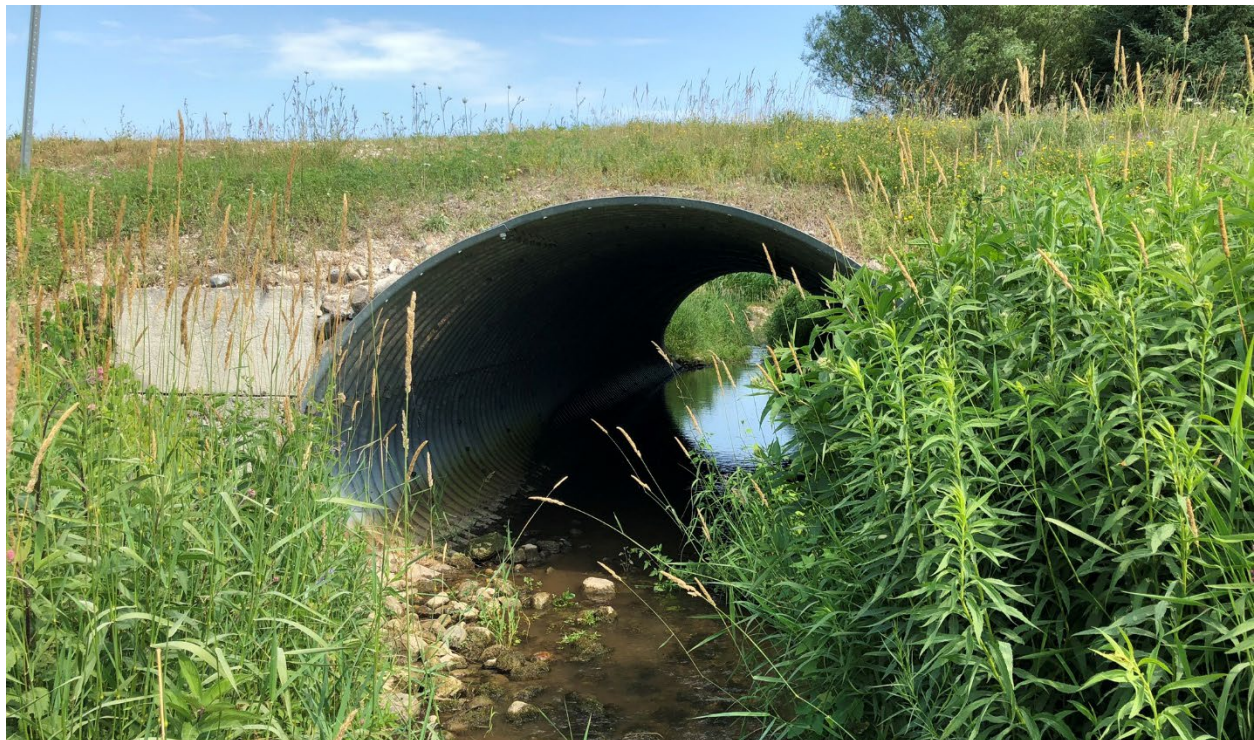
Structure No. 0022 generally appears to be in good condition and appears to have been installed within the last 20+/- years. Based on the current BCI, replacement is anticipated in approximately 20 years if the BCI continues to drop at a rate matching the projected deterioration curve used for this structure type; however, the BCI can continue to be monitored during future inspections and the years to replacement adjusted accordingly. The Municipality may wish to investigate if a barrier system is required at this location, but it appears the slopes are recoverable and that a guide rail system may not be warranted if the culvert ends are beyond the desirable clear zone.

Recommendation: No Capital Works is estimated to be required within the next 10 years

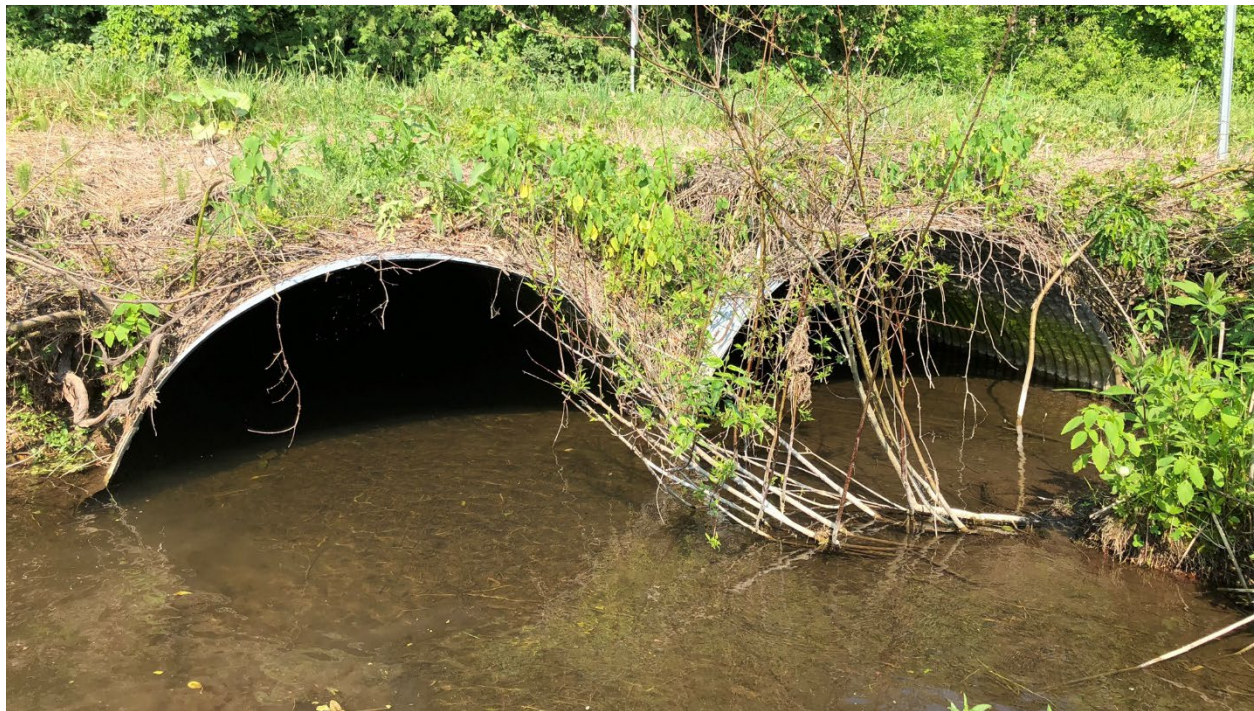
Structure No. 0023 is made up of twin-cell CSP culverts which appear to be in good condition overall, however, the culverts are nearly 50% filled with silt and consideration should be given to cleaning out the culvert to improve the hydraulic conveyance. Based on the current BCI, replacement is estimated to be required within approximately 16 years if the BCI continues at a rate matching the typical deterioration curve used for this structure type. In the interim, the Municipality should consider investigating whether the desirable clear zone is provided at this site, or whether a guide rail barrier system should be installed to help protect oncoming vehicular traffic given the steep slopes present.

Recommendation: No Capital Works is estimated to be required within the next 10 years

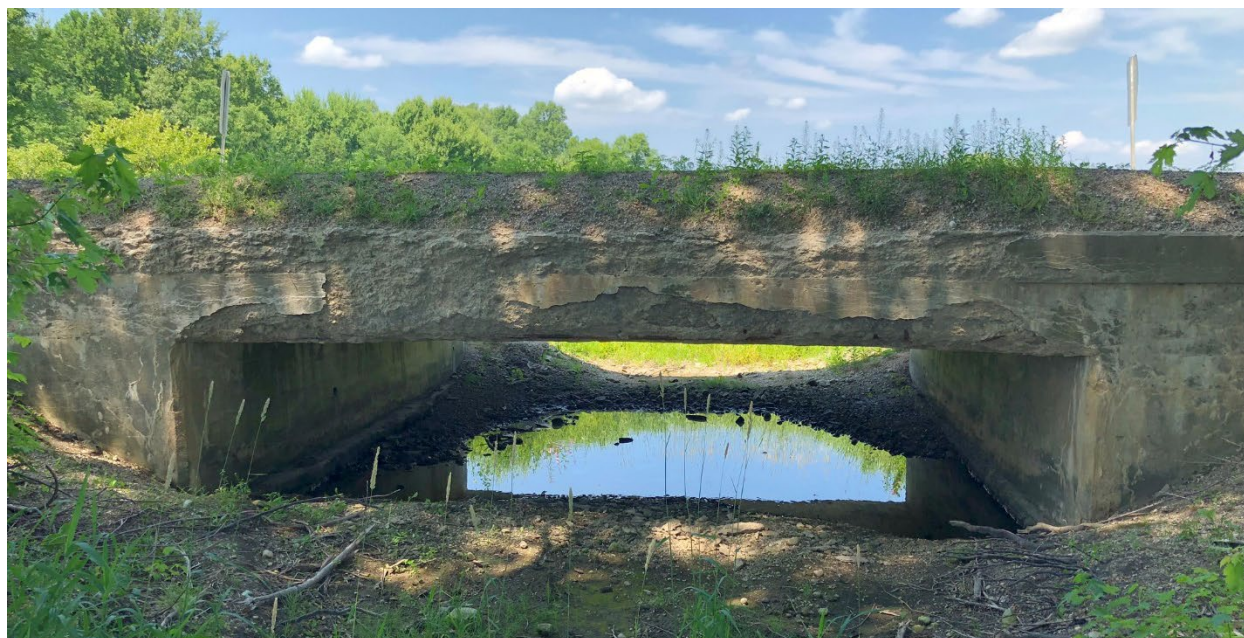
Structure No. 0024 generally appears to be in fair to poor condition with concrete deterioration throughout but most severe on the fascia. The bridge has approximately 0.5 m fill over the deck which may be contributing to the moisture damage noted. Based on the BCI, rehabilitation work would typically be recommended for this structure, however, given the limited clearance and relatively high cost of repairs versus replacement, replacement of the structure may be more economically efficient in the long term. The Municipality should investigate the need for this culvert given there is another watercourse directly adjacent to it and there has been no flow through the structure as far as Burnside's records go back (2014). If the culvert is redundant, the Municipality should replace the structure with a typical road corridor. Based on the current BCI, replacement/ removal should be considered within 9 years. In the meantime, roadside safety improvements should be considered at this location to help protect oncoming vehicular traffic.

Recommendation: Forgo rehabilitation and replace structure within 9 years

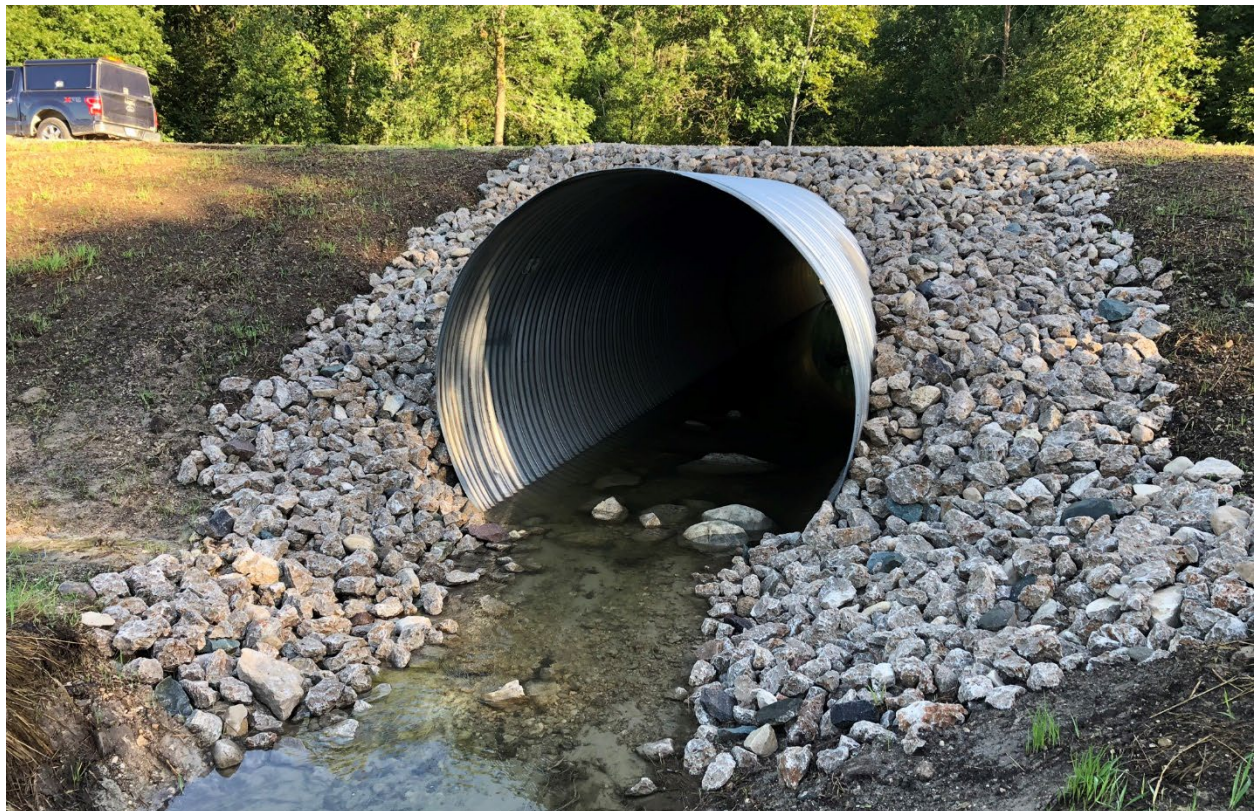
Structure No. 0025 was recently constructed in 2020, by the Municipality's own forces, and is generally in excellent condition. Consideration should be given to installing a proper guide rail system to help protect errant vehicles from the culvert end and watercourse.

Recommendation: Only maintenance work is recommended at this time

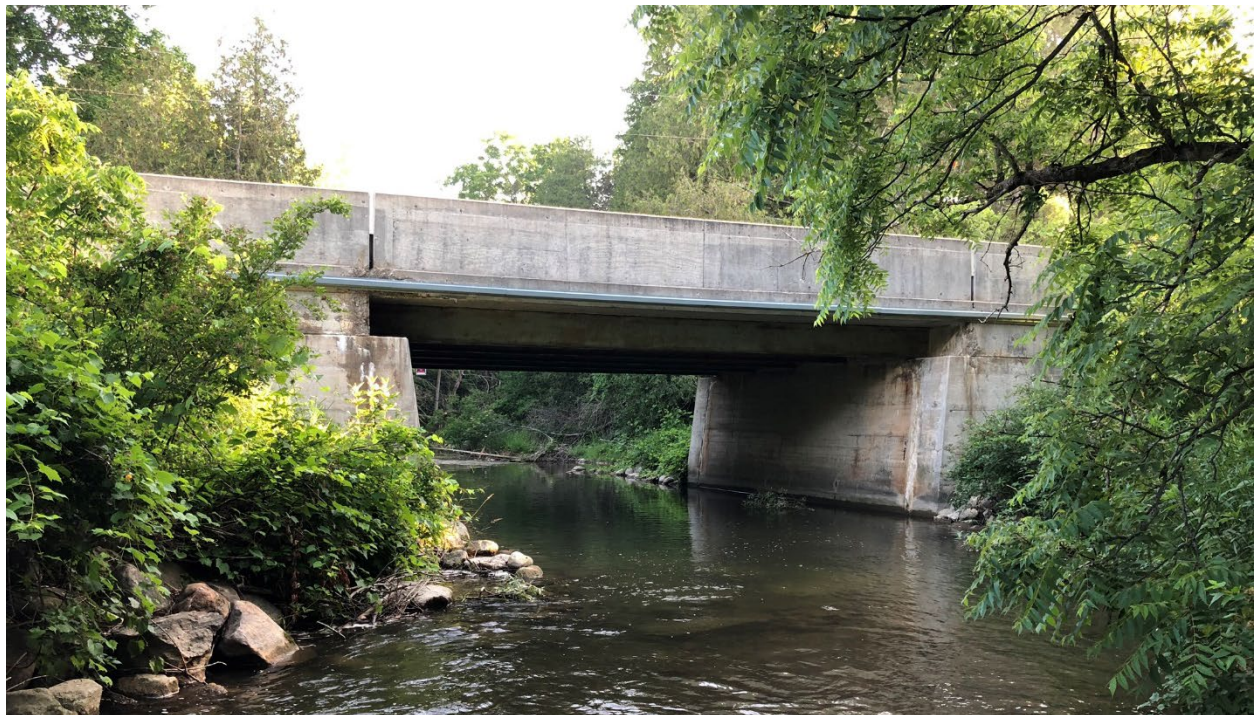
Structure No. 1001 generally appears to be in good condition with the exception of the previous water damage caused by the road salt/water leaking through the expansion joints in the barriers which were sealed after the 2014 inspection. The structure appears to have been previously rehabilitated and therefore the next capital works planned for the structure should be a replacement. Based on typical deterioration curves for rehabilitated structures, it is estimated that replacement will be required with approximately 20 years.

Recommendation: No Capital Works is estimated to be required within the next 10 years
