2020 Municipal Bridge Inspection Report

**Municipality of South Bruce
21 Gordon St. E, P.O. Box 540
Teeswater, ON N0G 2S0**

**R.J. Burnside & Associates Limited
449 Josephine Street P.O. Box 10
Wingham ON N0G 2W0 CANADA**

**September 2020
300042391.2020**

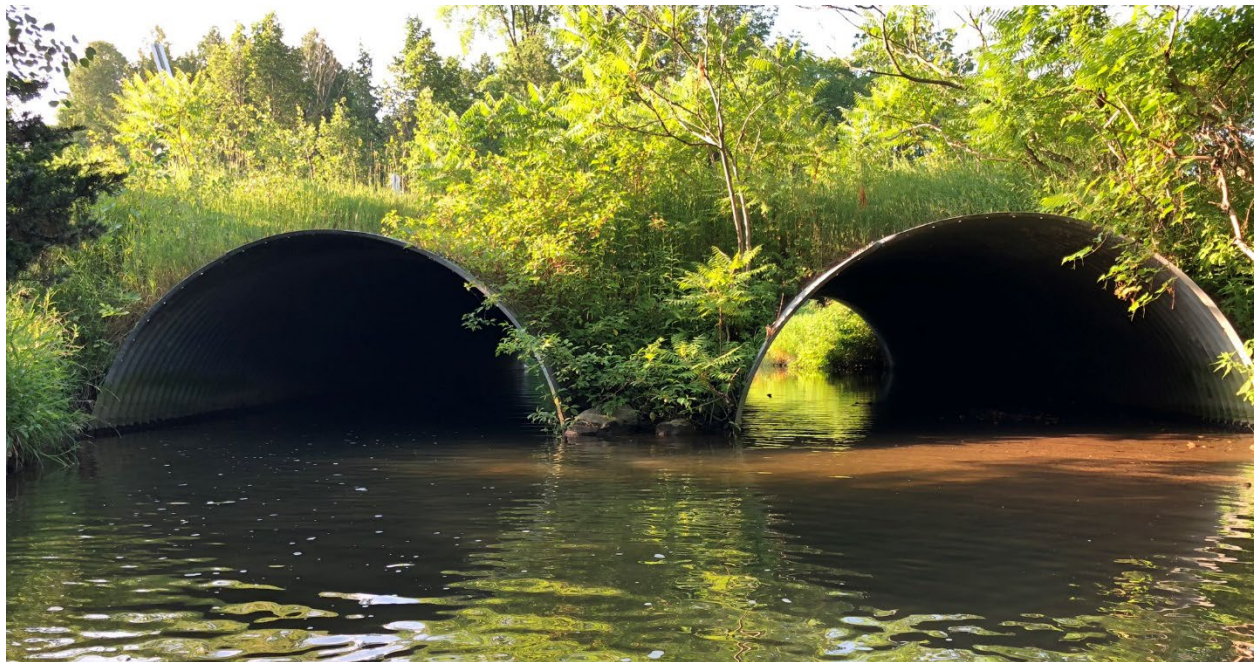
Structure No. 1002 is made up of twin-cell CSP culverts and generally appears to be in good condition. Based on the current BCI, replacement should be scheduled in approximately 17-18 years if the BCI continues to drop at a rate matching the typical deterioration curve used for this structure type. The minor deformation in the top of the east and west culvert should be monitored closely during future biennial inspections. If the deformations become greater than 10% of the culvert diameter, consideration should be given to establishing a monitoring program. The Municipality should also investigate whether the desirable clear zone is met at this site or if installation of a SBGR barrier system is warranted to help protect oncoming vehicular traffic.

Recommendation: No Capital Works is estimated to be required within the next 10 years

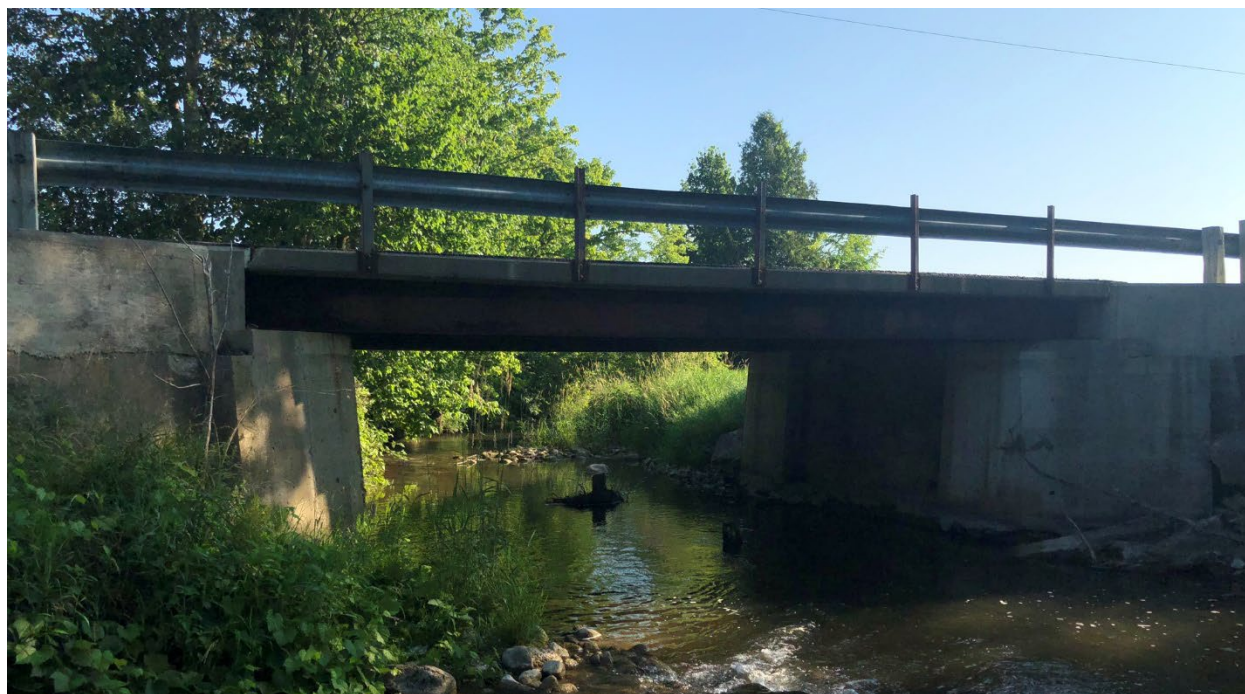
Structure No. 1003, which is estimated to have been constructed around 1940 has been previously rehabilitated and currently appears to be in generally fair condition overall. The structure is demonstrating continual signs of moisture penetration through the leaking expansion joints which is contributing to the damage of the girder ends and original abutments/ballast walls. The bridge's BCI has fallen from 63 to 58.1 since the 2014 inspection, which is mostly due to progression of corrosion noted on the girders. The structure has a load posting that may not allow for a large emergency vehicle to pass safely across the bridge. Given this load posting, the previous rehabilitation, and the relatively high cost associated with an additional rehabilitation, replacement of the structure is recommended as the BCI approaches 40, which is anticipated in approximately 8 years based on typical deterioration rates.

Recommendation: Structure replacement is recommended within 8 years

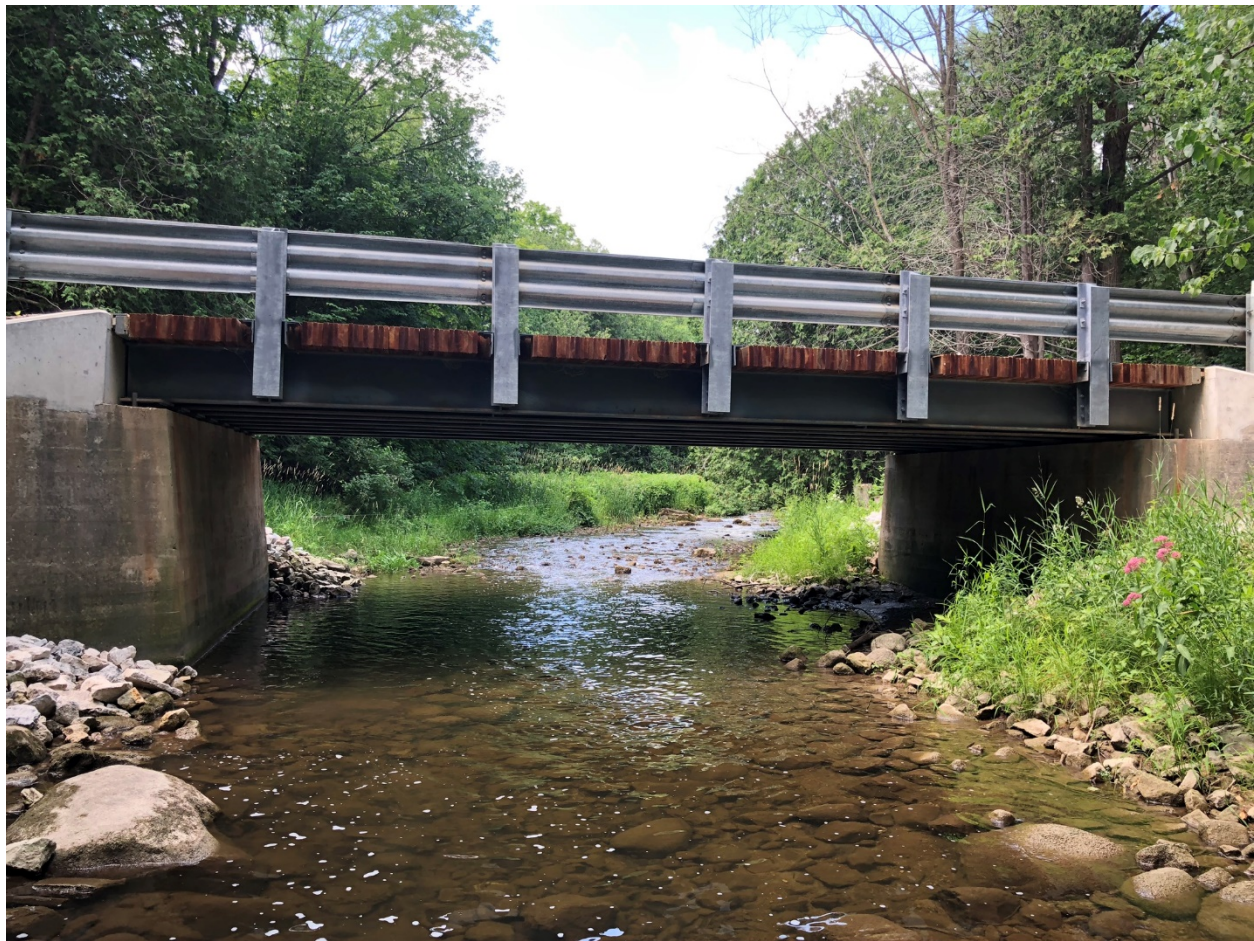
Structure No. 1006 had a superstructure replacement in 2019 and is generally in excellent condition overall. Only routine maintenance work is recommended at this point in time. It is typically only economical to complete 1 rehabilitation for a bridge of this size and therefore the next capital works for this structure should be replacement when the condition warrants.

Recommendation: No Capital Works is estimated to be required within the next 10 years

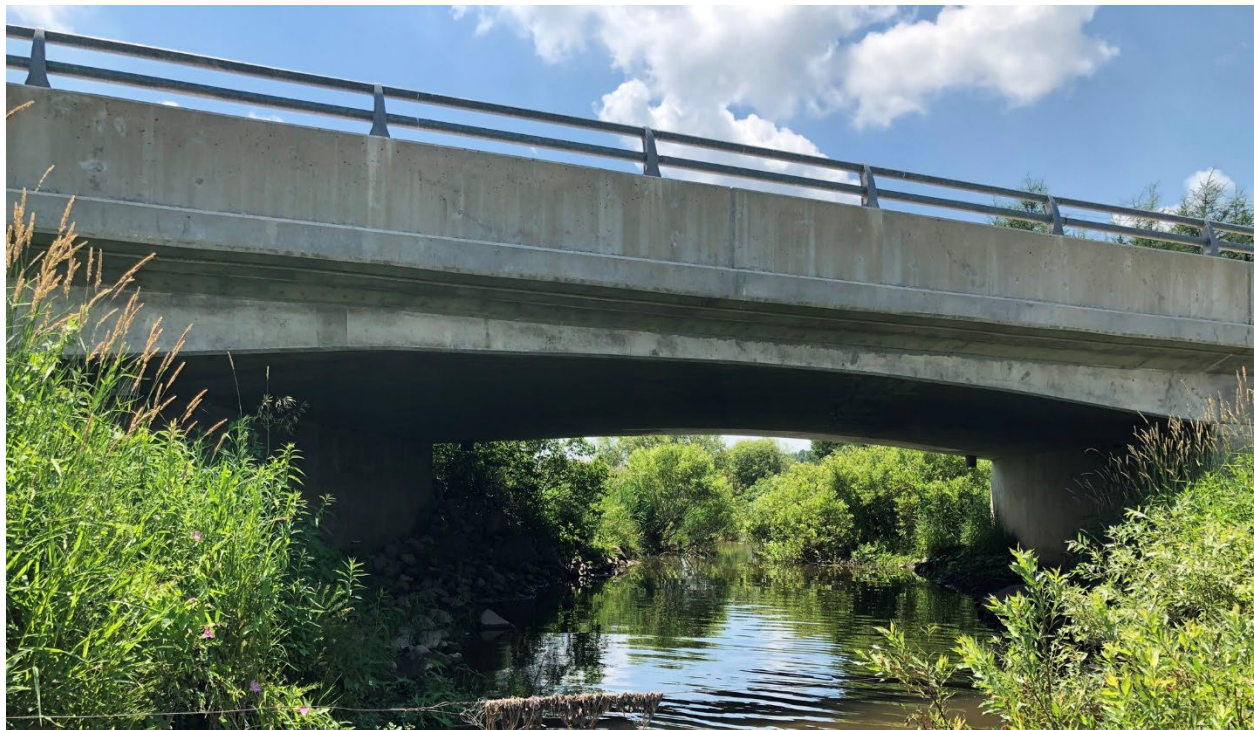
Structure No. 1007 is a concrete rigid frame which was constructed in 2007 and appears to be in excellent to good condition with only minor maintenance work recommended at this point in time. Based on the structure size, and type, rehabilitation work to help extend the service life of the structure is typically required as the structure degrades over time and should be planned for in approximately 18 years based on typical deterioration rates used for this structure type.

Recommendation: No Capital Works estimated to be required within 10 years.

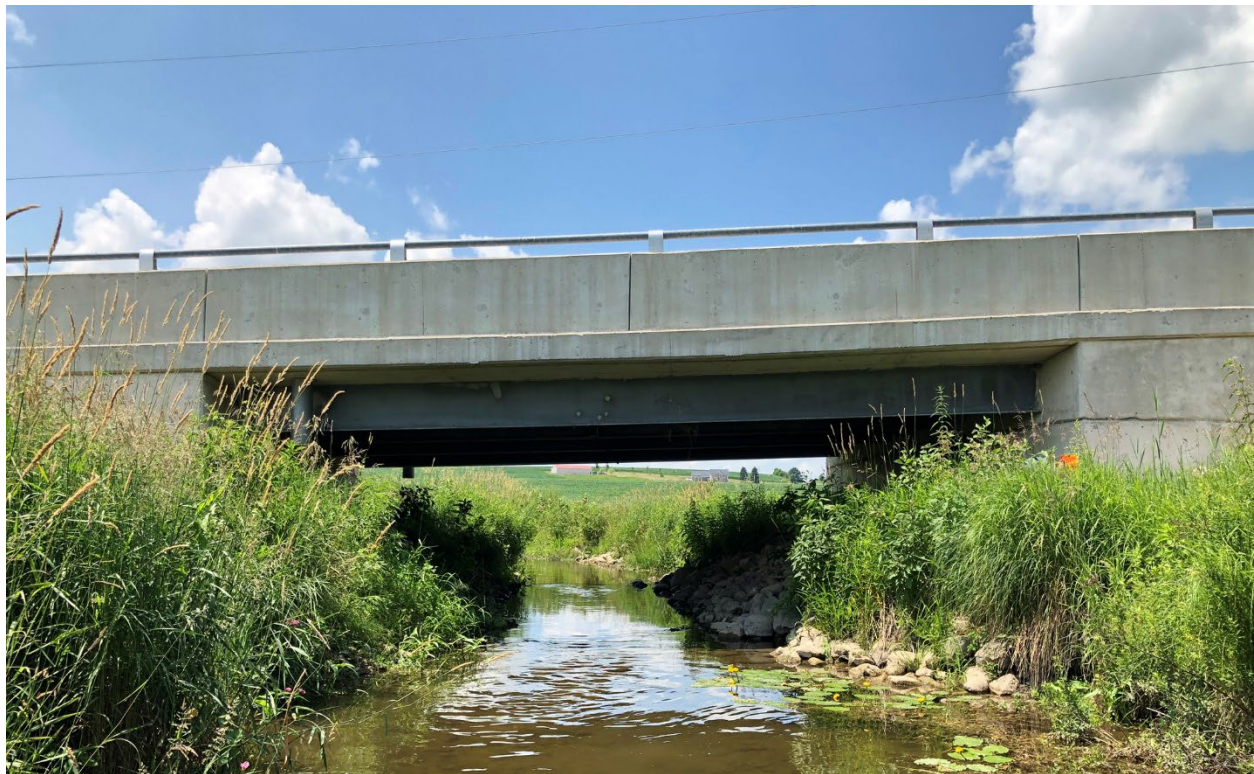
Structure No. 1008 was constructed in 2010 and is generally in excellent condition. Only minor maintenance work is recommended at this point in time, including installing hazard warning signs at the end of the guide rail to conform to modern standards. Consideration should be given to waterproofing and paving the structure to help reduce exposure of the concrete deck to salt laden water and to help extend the service life of the structure.

Recommendation: No Capital Works estimated to be required within 10 years. Future structure rehabilitation should be considered

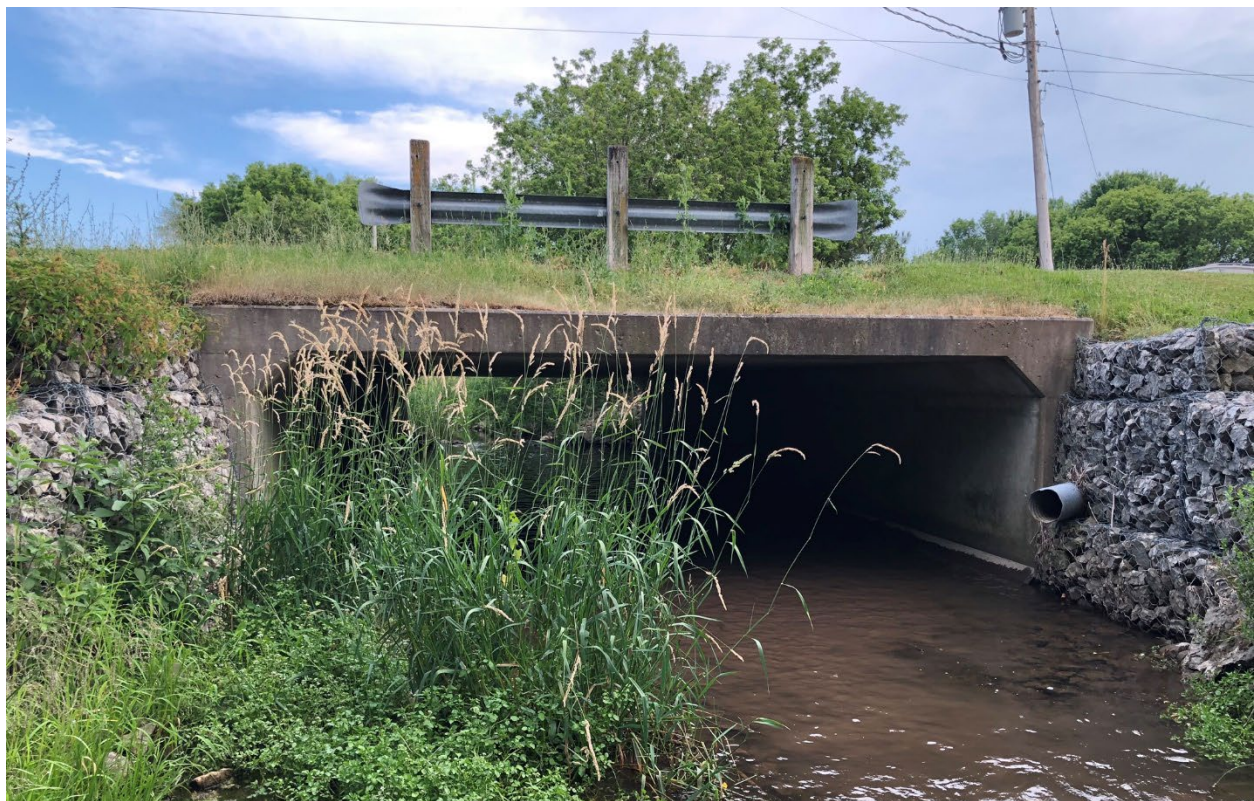
Structure No. 1009 was constructed in 1988 and appears to be in good condition showing no signs of further deterioration since the 2018 inspection. No repairs are recommended at this time. Based on the structure type, rehabilitations are not typically economical, and the structure should be planned for future replacement when condition warrants (20+ years). In the interim, the signs of movement in the gabion stone retaining walls should continue to be monitored during future biennial inspections.

Recommendation: No Capital Works estimated to be required within 10 years.

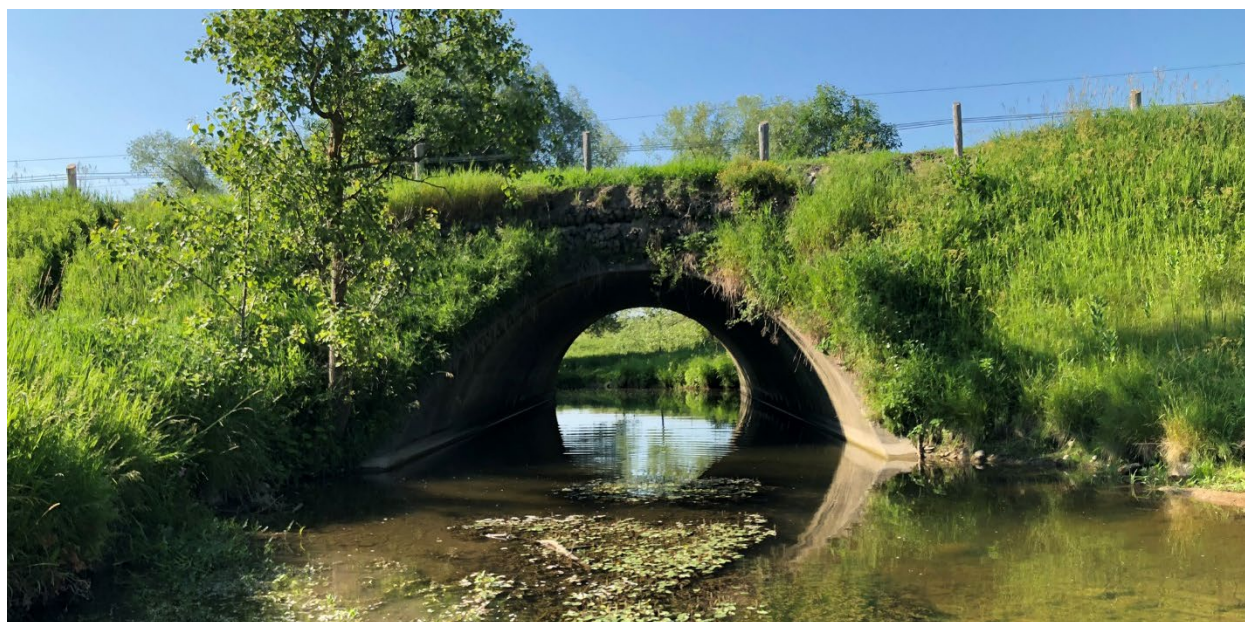
Structure No. 1011 is a concrete arch structure that generally appears to be in fair condition with signs of moisture penetration throughout the culvert barrel. Given the requirement for large excavations to complete waterproofing of the structure to prevent further moisture penetration, it is likely more feasible to provide a lining and grouting option. As such, a feasibility study has been recommended to compare lining and grouting versus replacing the structure and to confirm whether the reduced opening area caused by lining would be acceptable from a hydraulics standpoint. If re-lining is to occur, it is recommended that this work be completed in the near future, before deterioration reaches a point where replacement may be the only feasible option. If no rehabilitation work is completed, it is estimated that replacement will be required within 10 years based on the typical deterioration rates used for this structure type.

Recommendation: Major Rehabilitation is recommended as soon as possible

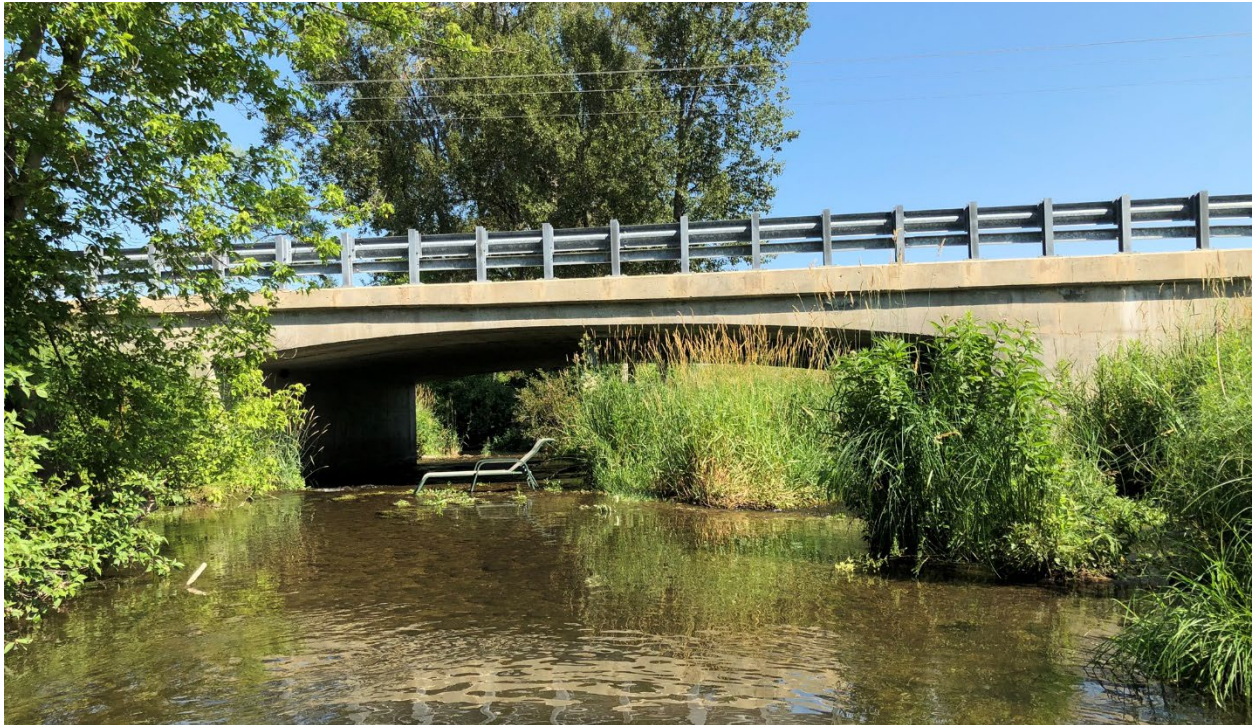
Structure No. 1012 is a concrete rigid frame that generally appears to be in good to fair condition but is demonstrating signs of moisture penetration through the exposed concrete deck. Based on the current BCI and structure type, this structure is a good candidate for future rehabilitation work which should be scheduled in approximately 5 years based on typical deterioration rates. Concrete repairs, waterproofing and paving the exposed deck will help extend the service life of the structure.

Recommendation: Major Rehabilitation is recommended within 5 years

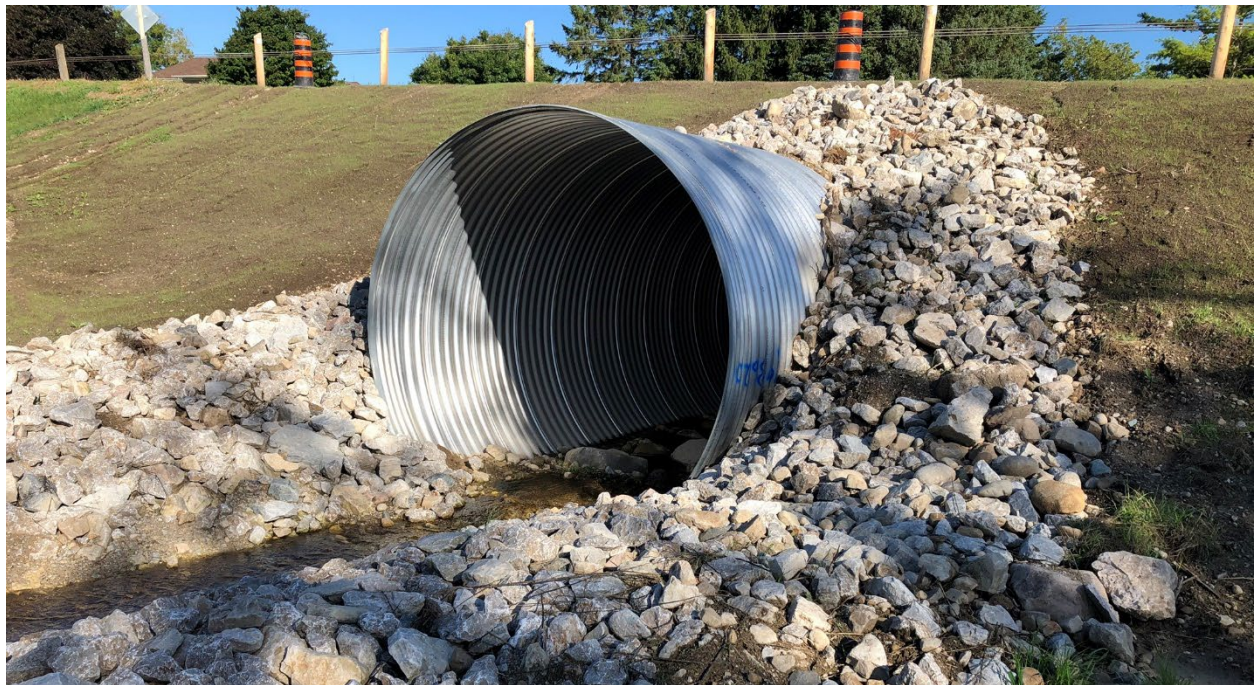
Structure No. 0025 was recently constructed in 2020, by the Municipality's own forces, and is generally in excellent condition.

Recommendation: No Capital Works is estimated to be required within the next 10 years

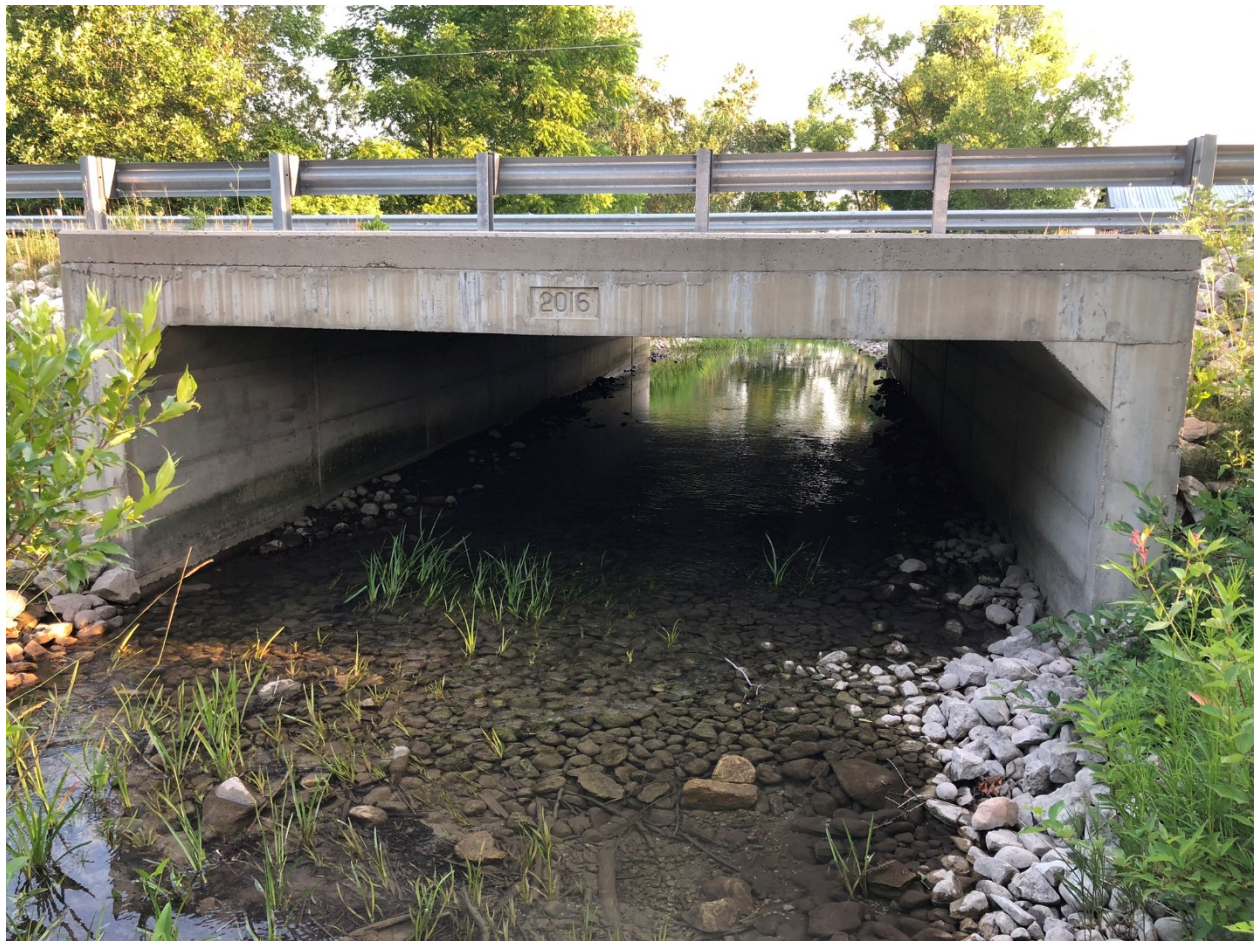
Structure No. 1014 was replaced in 2016 and is in excellent condition. No capital work is recommended at this time; however, the Municipality should complete routine maintenance on this structure, including cleaning of the wearing surface and exposed concrete as part of their annual maintenance program.

Recommendation: No Capital Works estimated to be required within 10 years.

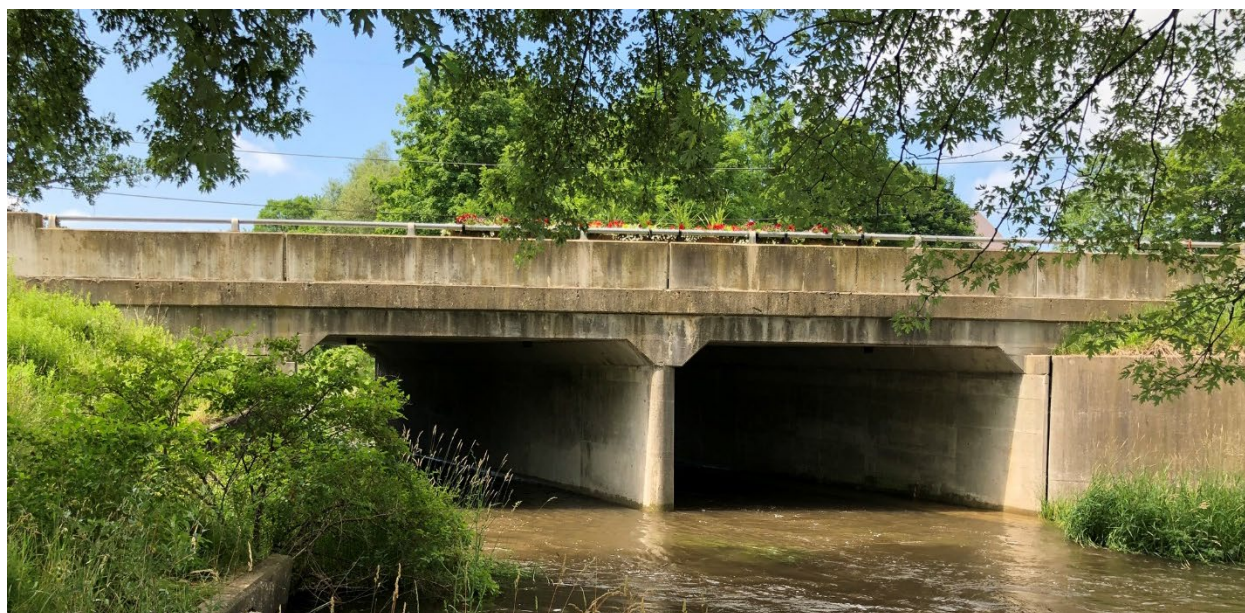
Structure No. 1016 generally appears to be in good condition but is demonstrating signs of potential moisture penetration through the concrete deck, based on efflorescence stained cracking in the soffit. Given the size and the amount of traffic using this structure, this structure is an ideal candidate for future rehabilitation work. Based on typical deterioration rates for this structure type, a rehabilitation is estimated to be required in approximately 6 years, when the BCI reaches 60. It is recommended that a detailed deck condition survey be completed prior to the rehabilitation to confirm levels of chloride content in the deck slab and to confirm extent of repairs required. The current estimated rehabilitation above includes for staged construction to allow the road to remain open during works. Rehabilitation work will help extend the service life of the structure, but if it is not completed, it is estimated the structure will need to be replaced in approximately 16 years based on typical deterioration rates.

Recommendation: Major Rehabilitation is recommended within 6 years

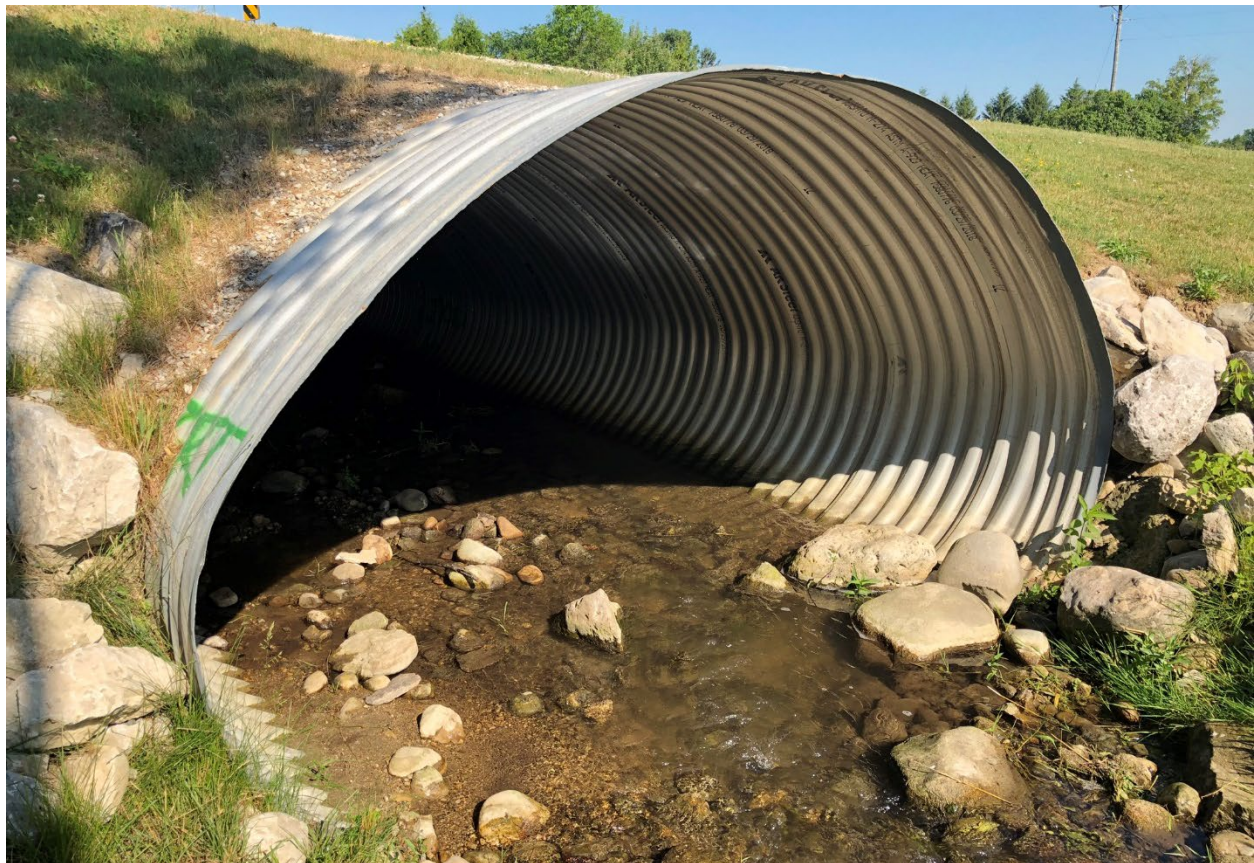
Structure No. 1017 was recently replaced by the Municipality using their own forces in 2018 and is currently in excellent condition; however, some gaps were noted at joints. The gaps are currently filled with an expandable sealant but deterioration of this material in the future could lead to loss of the culvert backfill material. The replacement cost estimate is based on the Municipality completing the future replacement work; however, if a Contractor is to be procured, the costs for replacement will likely be higher than noted.

Recommendation: No Capital Works is estimated to be required within the next 10 years

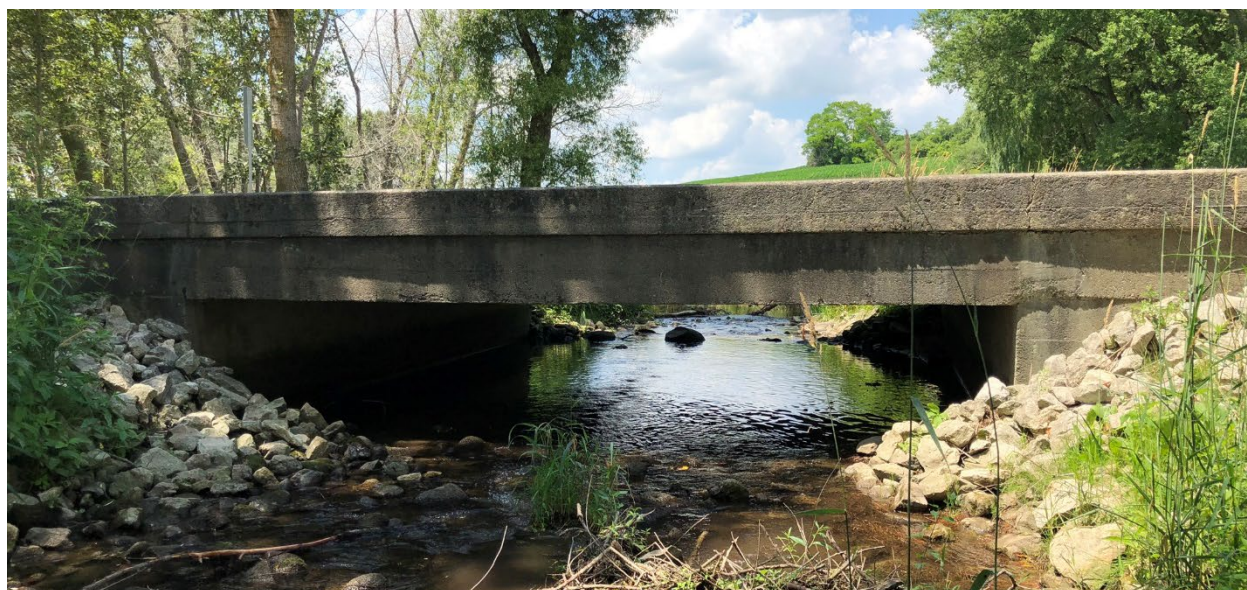
Structure No. 1018 is generally in good condition, however, there are cracks and delamination present in the soffit which indicate the possible presence of chloride and moisture penetration through the deck. Consideration could be given to removing the fill, repairing concrete, installing a barrier system, waterproofing and paving the bridge to help prevent further chloride and moisture penetration and extend the overall service life of the structure. However, given the small size of the structure, and narrow platform width, it is likely more economically efficient to consider forgoing a rehabilitation and replace the bridge as the BCI approaches 40. Based on the current BCI and typical deterioration rates, it is anticipated that replacement would be required in approximately 15 years, but the deterioration rate can be monitored during future inspections and the timeline adjusted accordingly.

Recommendation: Forgo rehabilitation and replace structure in future (replacement timeline estimated to exceed 10 yrs)

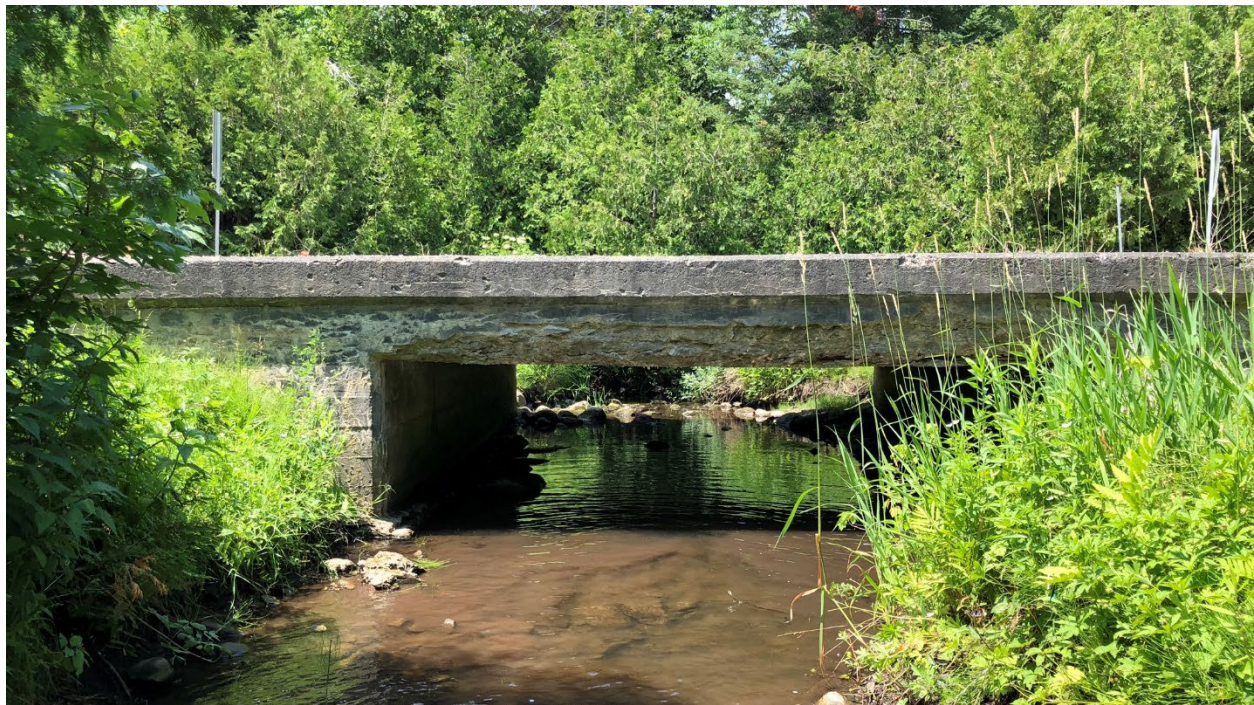
Structure No. 1019 is in generally poor condition with severe concrete disintegration and unsound concrete noted throughout the curbs, exterior soffit and wingwalls. Given the age, small span, limited clearance, narrow platform width and high repair costs associated with the extent of deterioration that has already occurred, rehabilitating this structure is not considered an economically feasible option. It is recommended that this structure be replaced within 2 years given the extent of defects noted on key structural elements.

Recommendation: Structure replacement is recommended within 2 years

Rehabilitation/Repair Required	Priority	Estimated Cost
Type A concrete repairs to deck top,	N/A	\$10,000.00
Type B concrete repairs to soffit,	N/A	\$34,000.00
Type C concrete repairs to abutment walls, wingwalls,	N/A	\$30,000.00
Remove fill, waterproof and pave	N/A	\$20,000.00
Install barrier system	N/A	\$30,000.00
General Items - Insurance, Mobilization, Access etc.	N/A	\$75,000.00
Rehabilitation Cost Subtotal		\$199,000.00

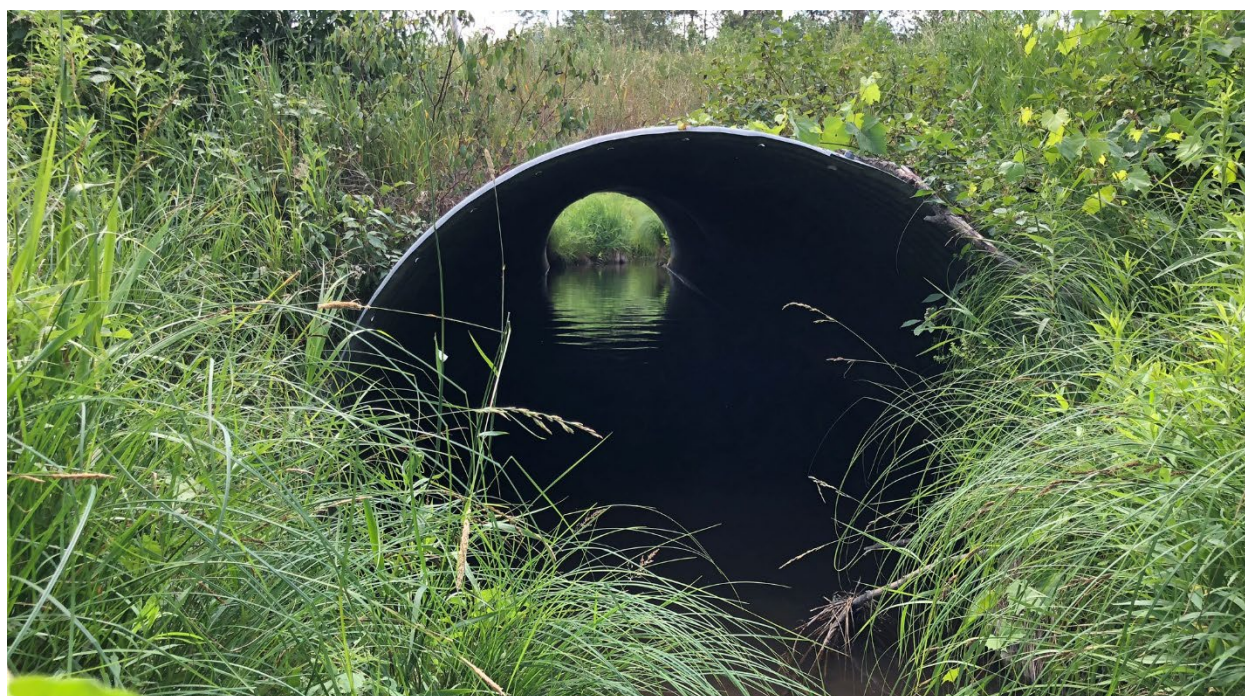
Structure No. 1020 is a multi-plate CSP with a span less than 3 m. The structure was added to the bridge inspection list in 2014 as deformations were observed throughout the culvert. The overall physical condition of the culvert is good with no significant surface corrosion; however, cupping is present over approximately 5.5 m of the culvert length, which has a negative effect on the overall BCI rating of the structure. The length and magnitude of the cupping has been monitored since 2014 and has not increased but should continue to be monitored during biennial inspections. Based on the current BCI and typical deterioration curves, the remaining service life of the structure is approximately 10 years. It is likely however that this structure will outperform this timeframe given that the cupping is not actively progressing and considering that the structure is not deteriorating at typical rates for the current BCI. In the interim, the Municipality should consider investigating the need for guiderail at this location.

Recommendation: Structure replacement is recommended within 10 years

Roadside Protection Repairs	Priority	Estimated Cost
Investigate need for Guide Rail	1 to 5 Years	\$1,000.00

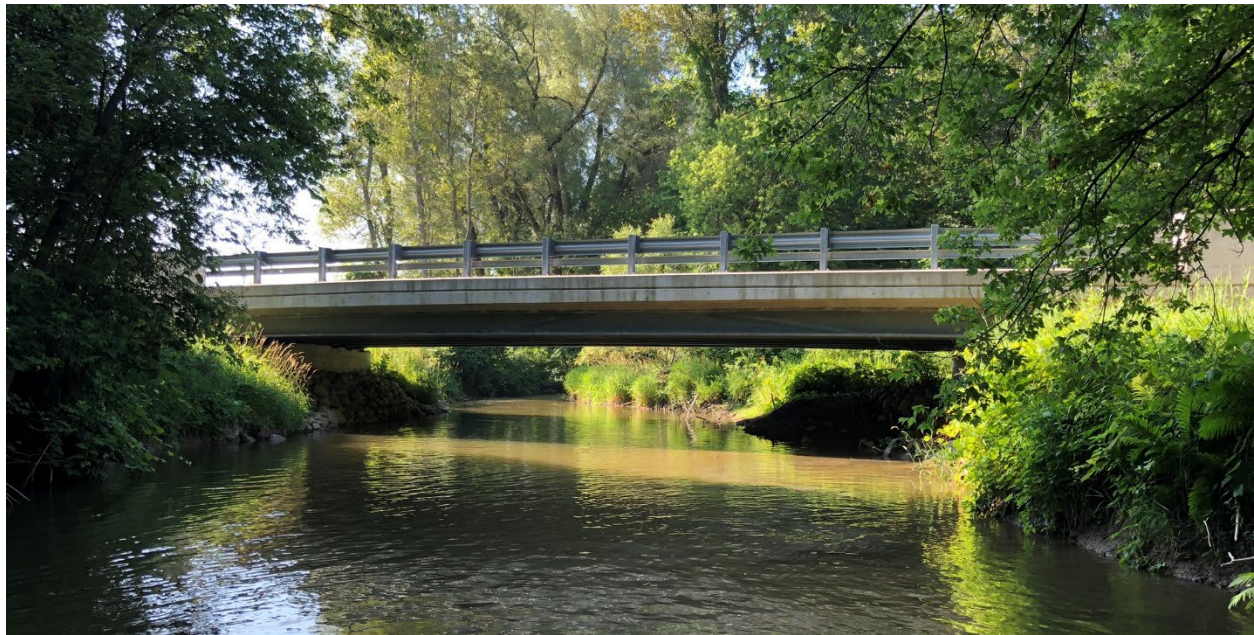
Structure No. 1021 was replaced in 2016 and is in excellent condition. Although only minor deficiencies were noted, portions of element quantities have been gradually transferred from excellent to good condition based on age and level of exposure to account for typical aging as outlined in the OSIM Manual. Routine maintenance should be completed to help maximize the lifespan of the structure.

Recommendation: No Capital Works estimated to be required within 10 years.
